LE & A L. EVERETT & ASSOCIATES

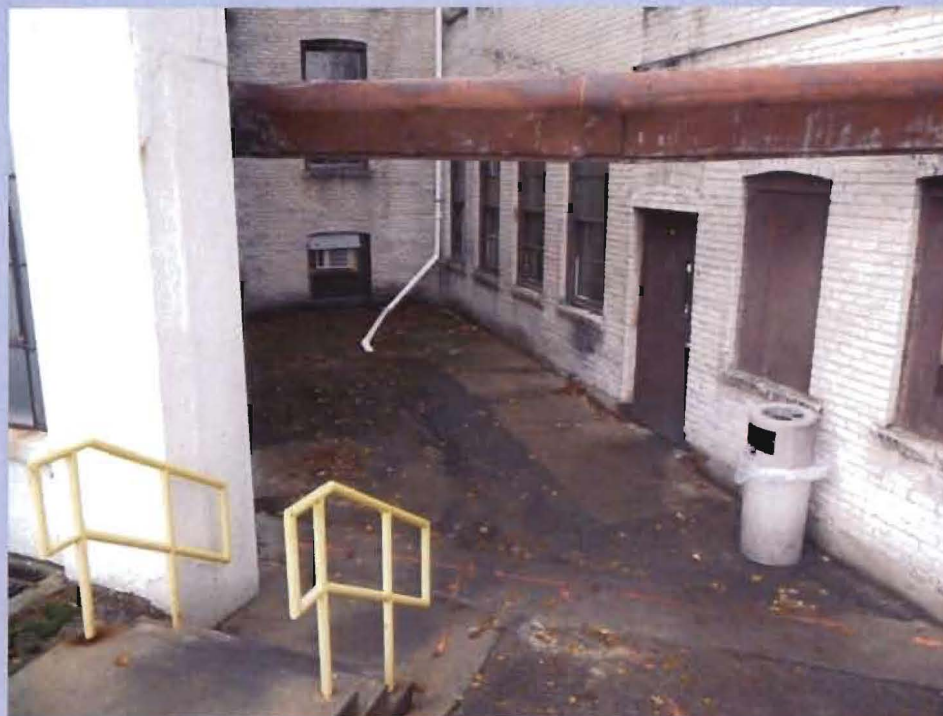
Picture 1

Showing the location of the above ground PCE storage tank. Note, no indication of soil samples taken. Note that the surface flow is towards the front of the picture.

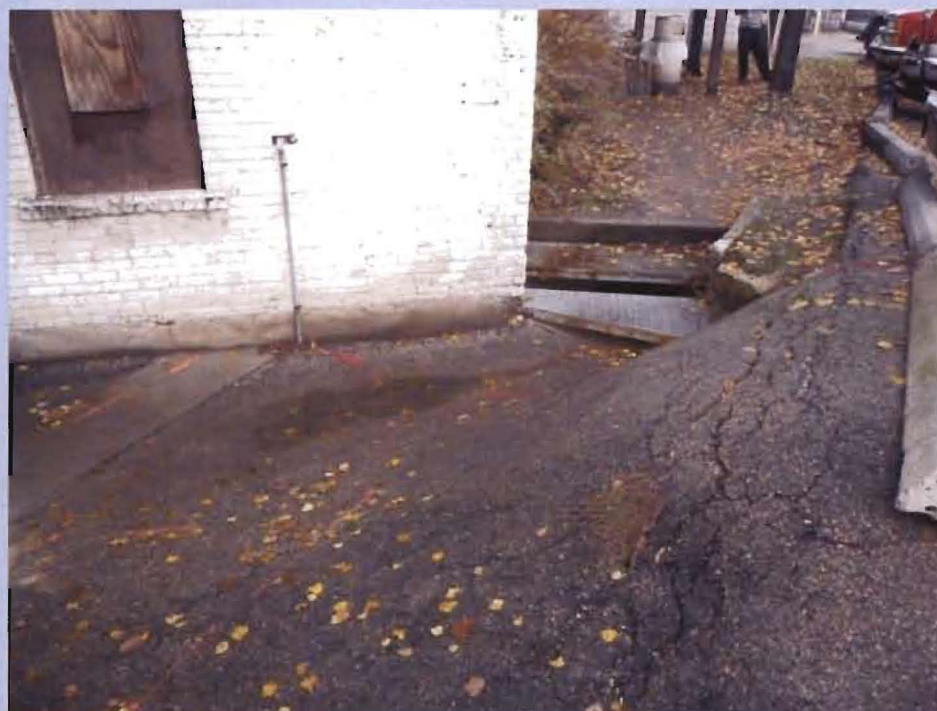
Picture 2

Showing the drainage from the above ground storage tank area flows to a subsurface drain heading towards the northern part of Madison-Kipp property.

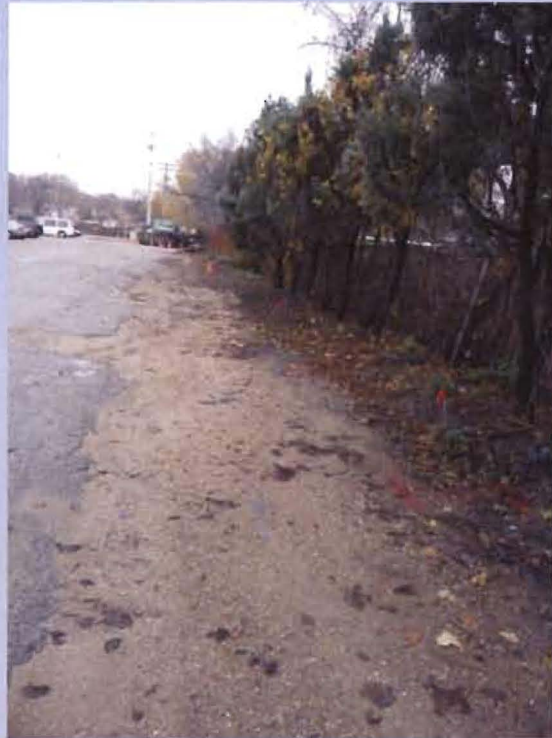
Picture 3

Looking towards the northeastern side of the Madison-Kipp parking lot showing how the drainage is to the east into the neighboring family properties.

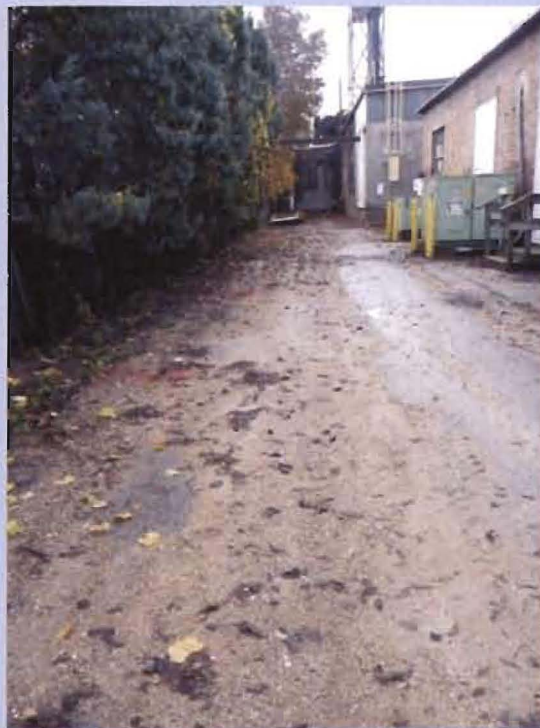
Picture 4

Looking south and noting how the drainage is to the east into the neighboring properties.

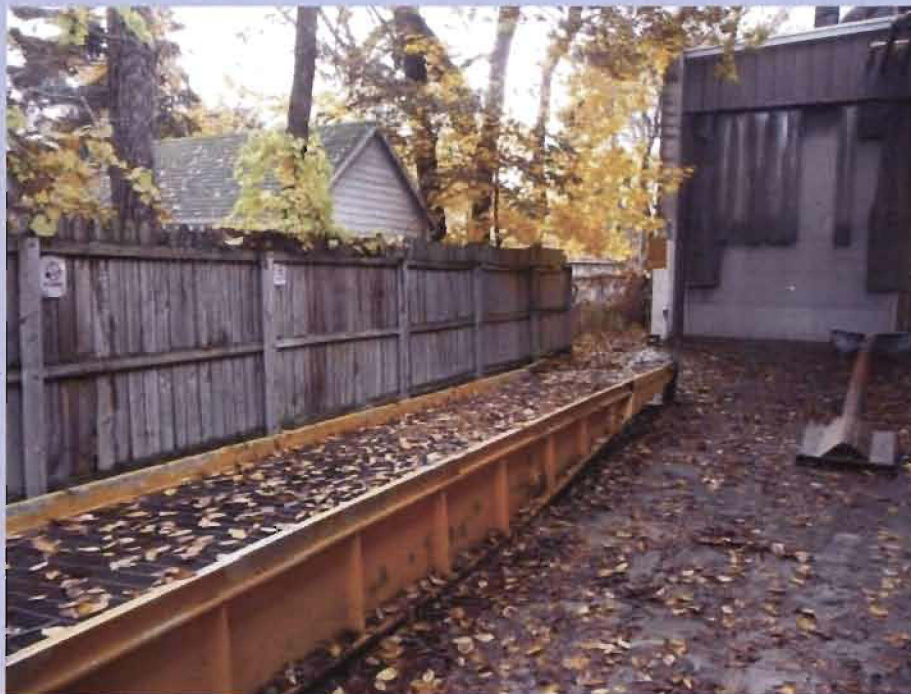
Shows the location of MW- 5, the highest contaminated groundwater well, relative to the neighboring buildings directly adjacent to the fence line.

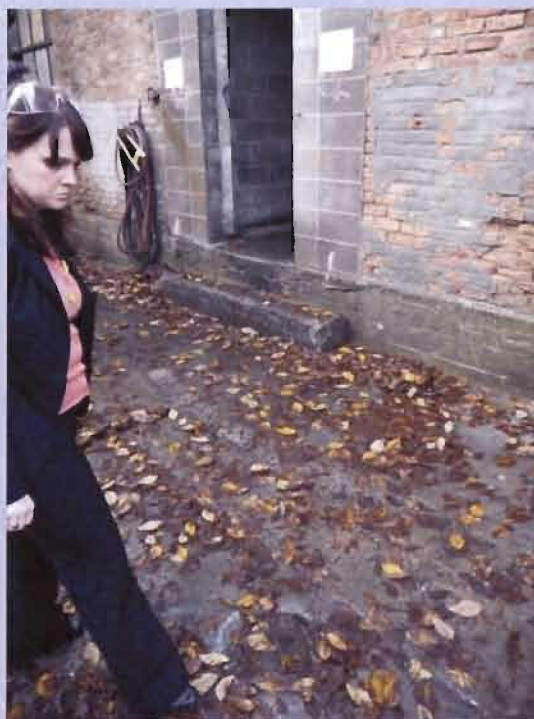
Shows Madison-Kipp's lawyer's foot adjacent to the most contaminated well MW- 5. Note the door in the background which was used by Madison-Kipp employees to dump buckets onto the bare ground (see Lenz deposition)

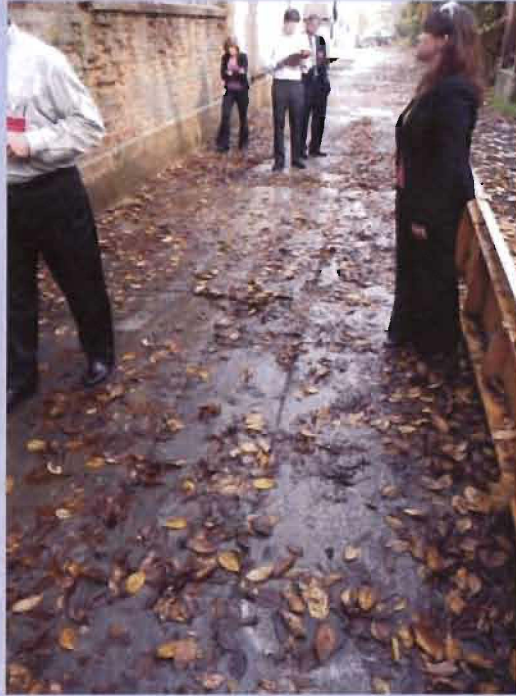
Shows MW 5, the most contaminated of the groundwater wells. Note how the surface flow moves down gradient towards the north.

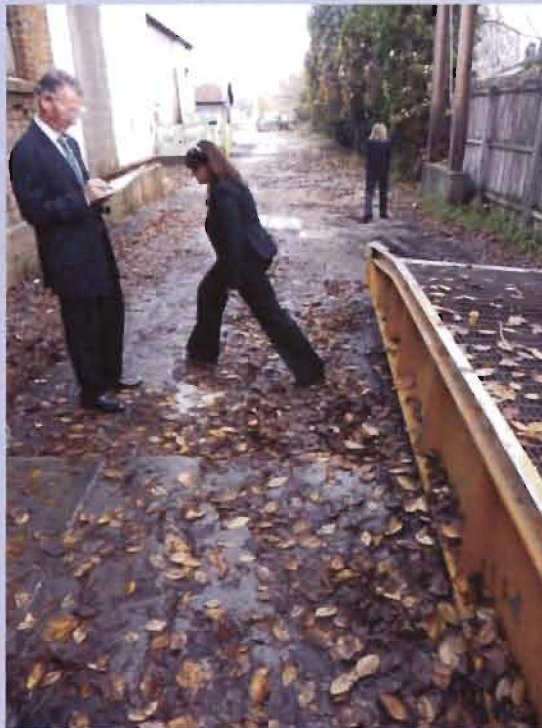
Shows how flow from the MW- 5 area flows down gradient into the neighboring properties.

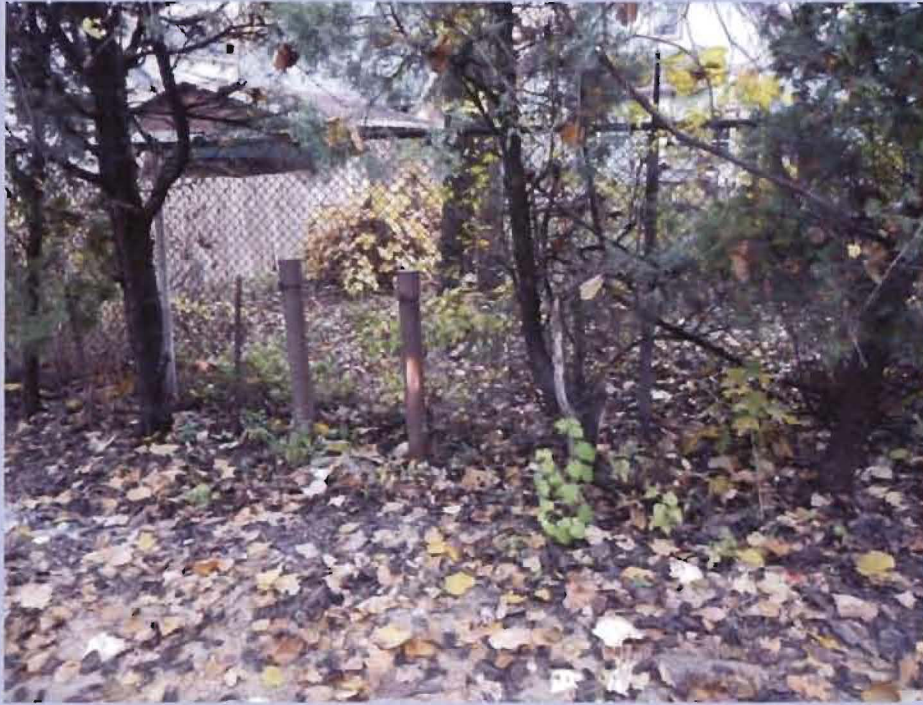
Taken from the Madison-Kipp side of the fence showing how overland water flow can easily migrate off site into the neighboring properties.

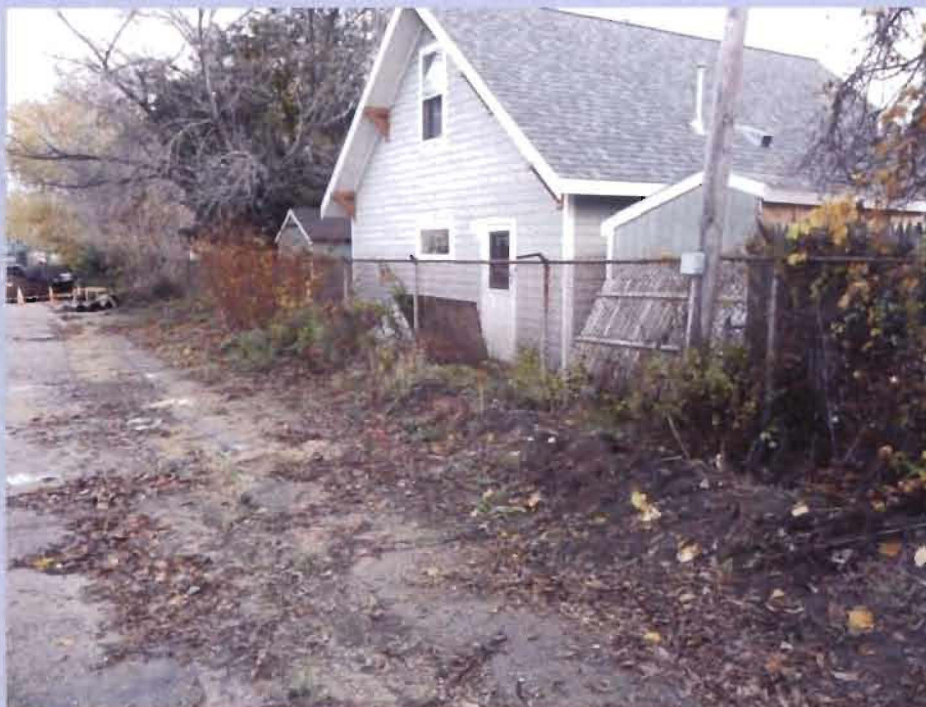
Shows how the backdoor of some homes open up immediately adjacent to the parking lot and to the Madison-Kipp fence.

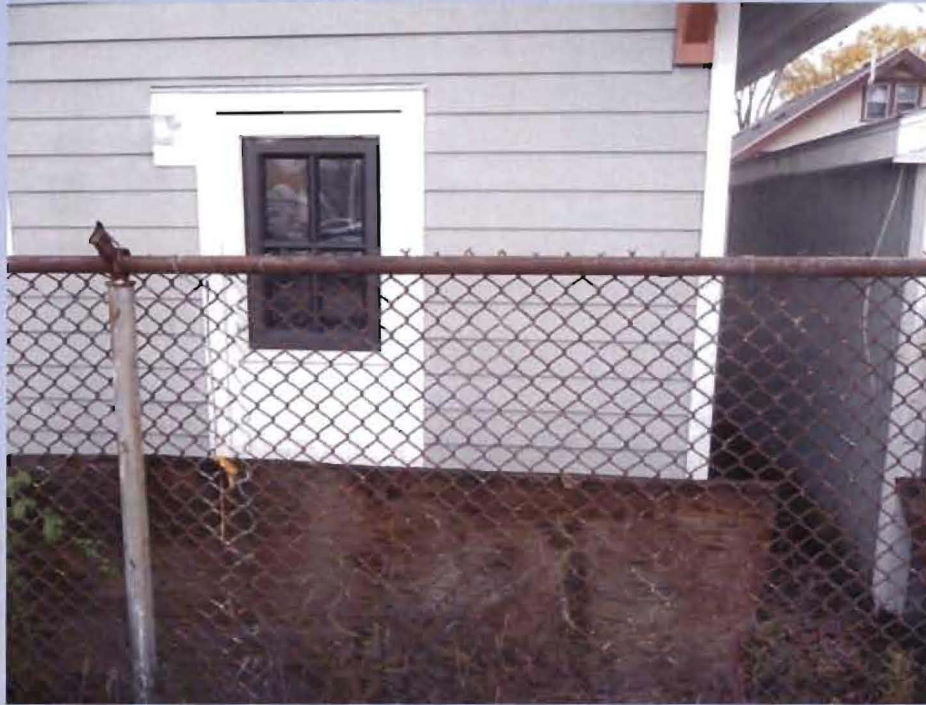
Shows that the backdoor of properties would be very close to touching the fence when they were opened.

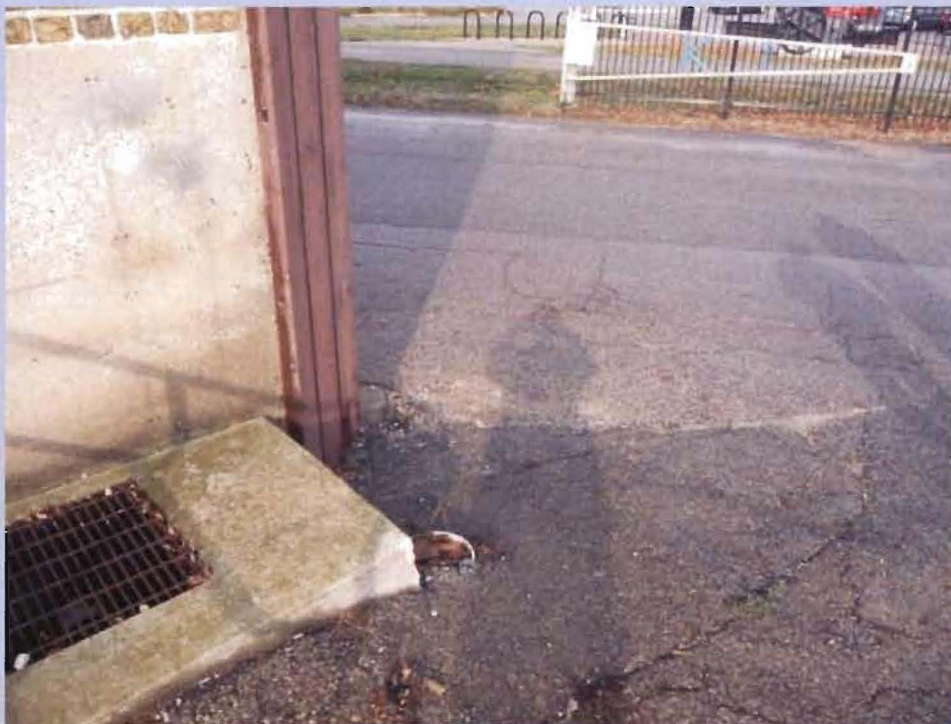
Shows a drainage grate down gradient from the above ground storage area. The subsurface sewer then turns towards the north east towards the bicycle path noted in the top of the picture

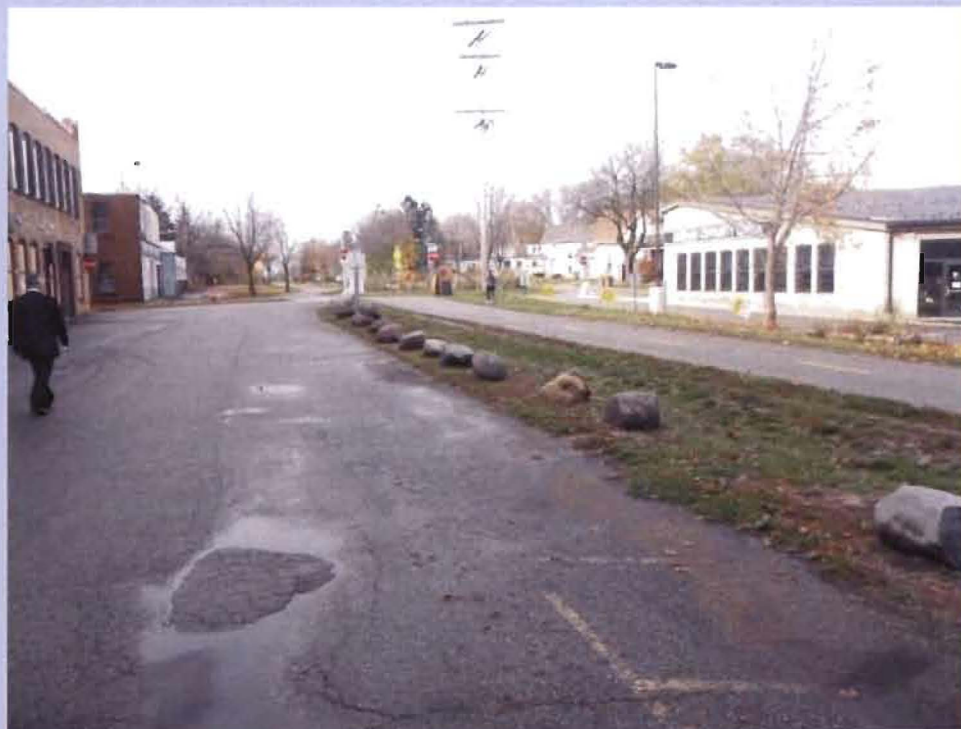
Shows the bicycle path on the northern boundary of the Madison-Kipp property and the green belt which would receive the sewer discharge to the northeast.

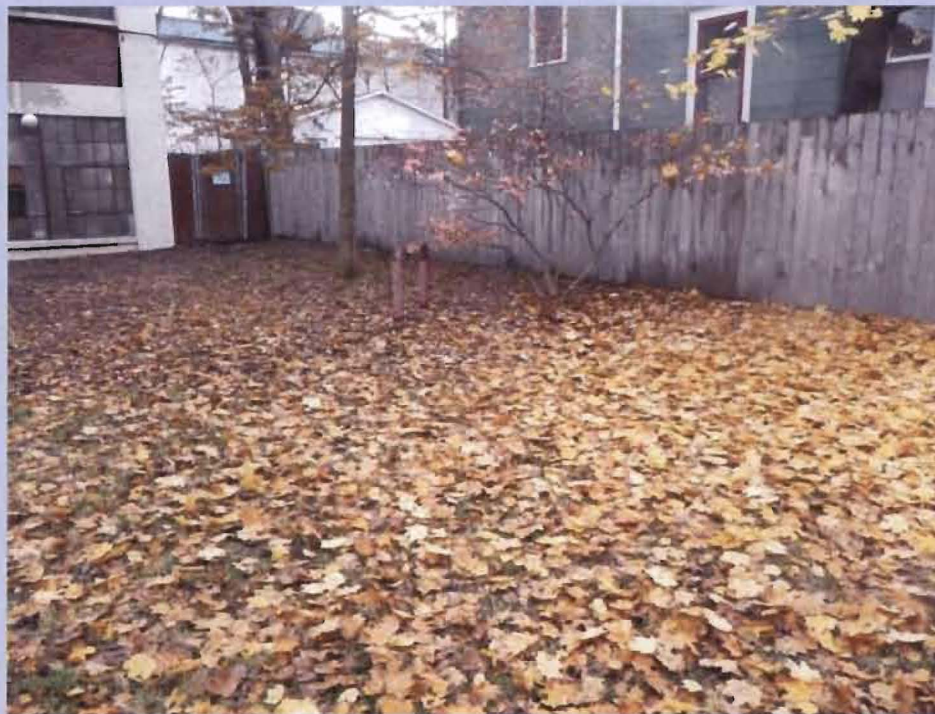
Shows the proximity of neighboring windows immediately adjacent to the Madison-Kipp facility. Notice that the gate does not have a hazardous waste warning sign.

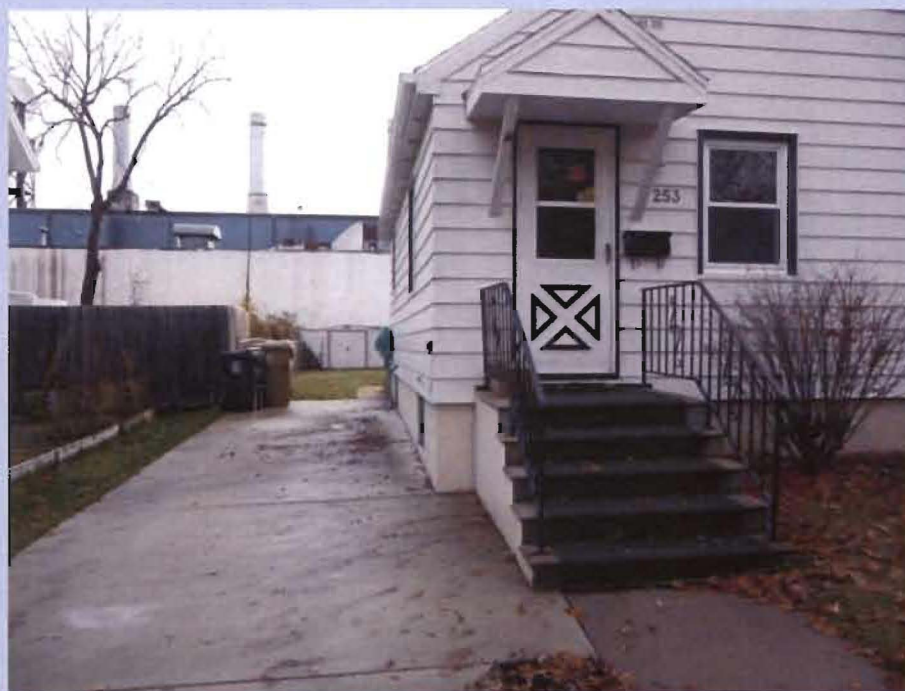
Shows the huge roof stacks associated with the Madison-Kipp facility directly adjacent to the backyards of homes.

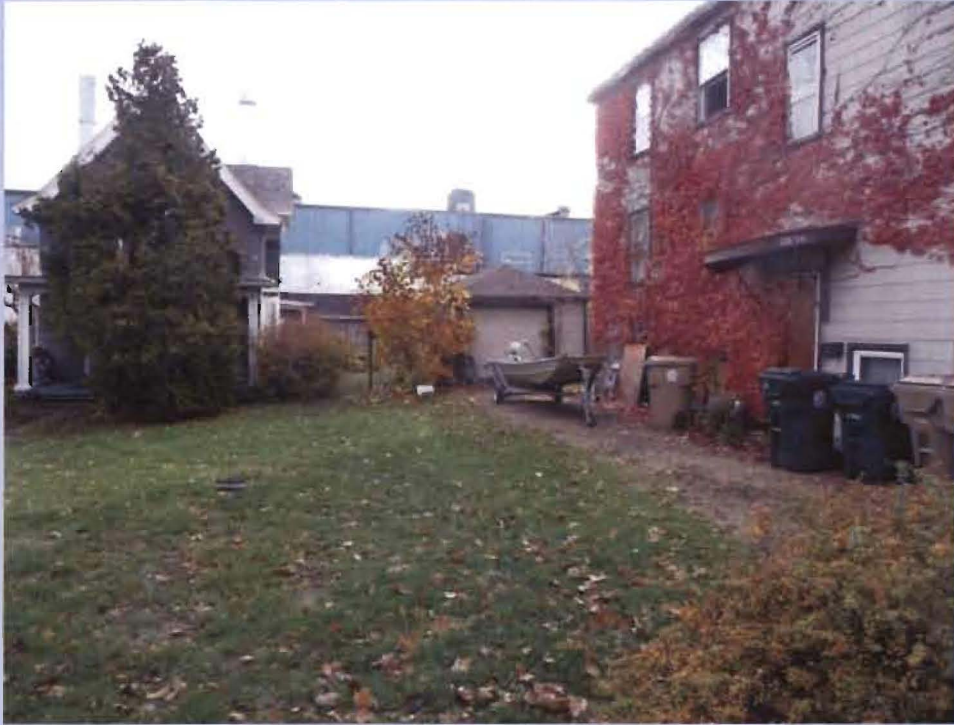
Shows three huge Madison-Kipp smoke stacks directly adjacent to homes. The home on the left appears to be one of the closest homes to the smoke stacks and appears to be abandoned.

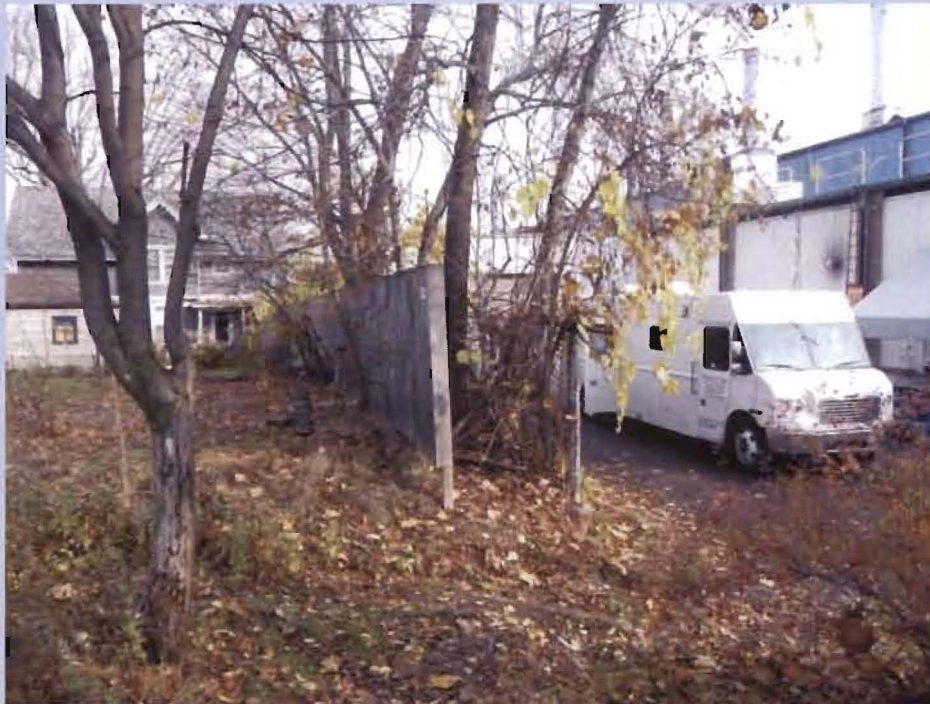
Shows the Madison-Kipp property on the right hand side and the neighboring property demonstrating how close the homes are to the Madison-Kipp facility.

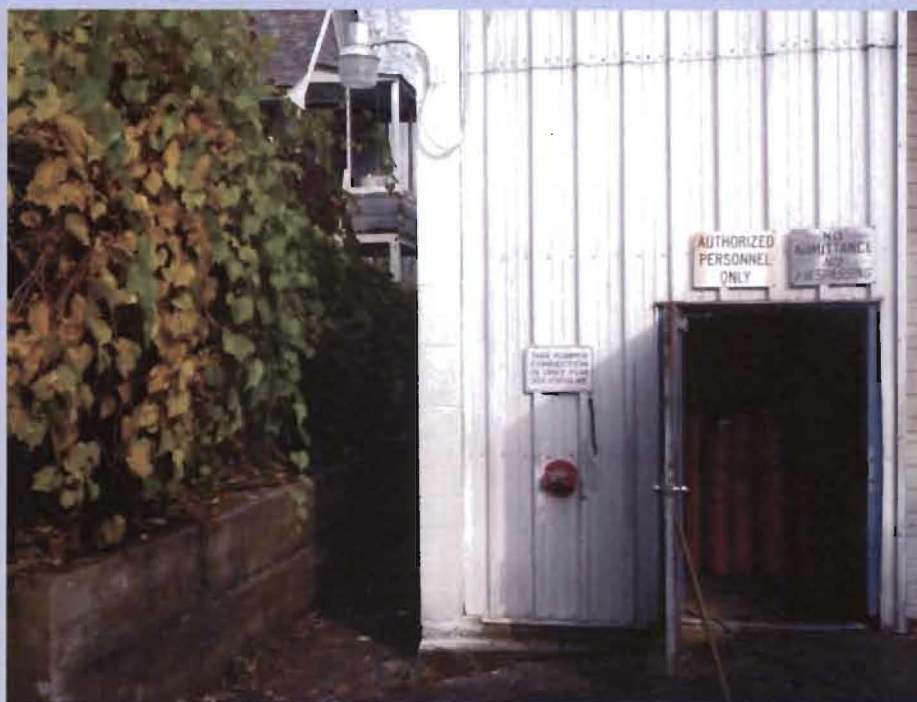
Looking north from the southwestern parking lot. Note narrow passage way between Madison-Kipp property and home at approximately 269 Waubesa Street.

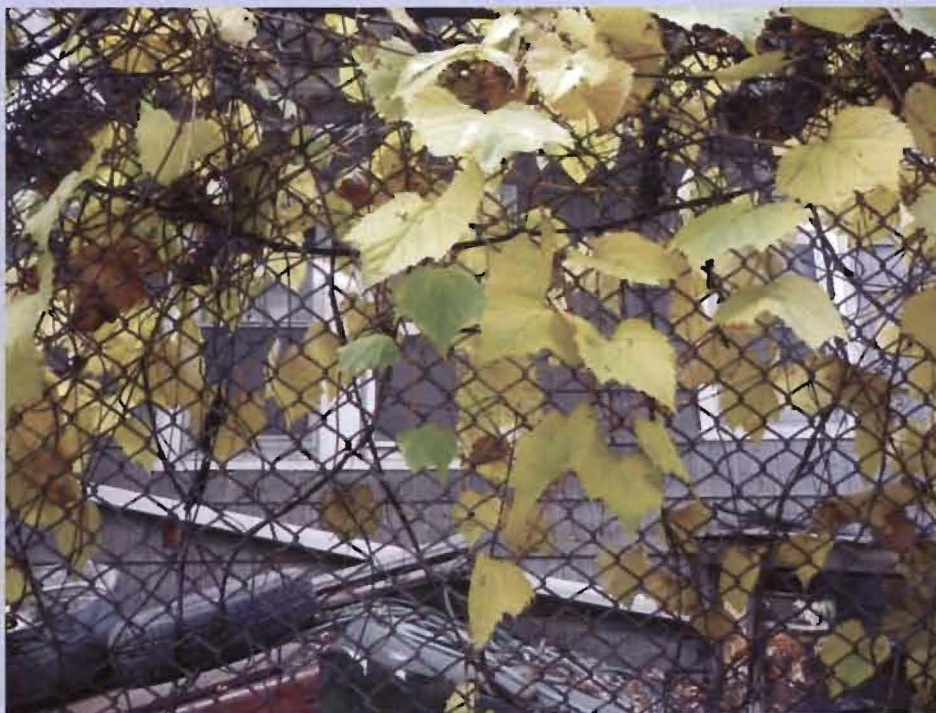
Standing along the narrow alley way on the west side of Madison-Kipp looking directly into the windows of immediately adjacent homes.

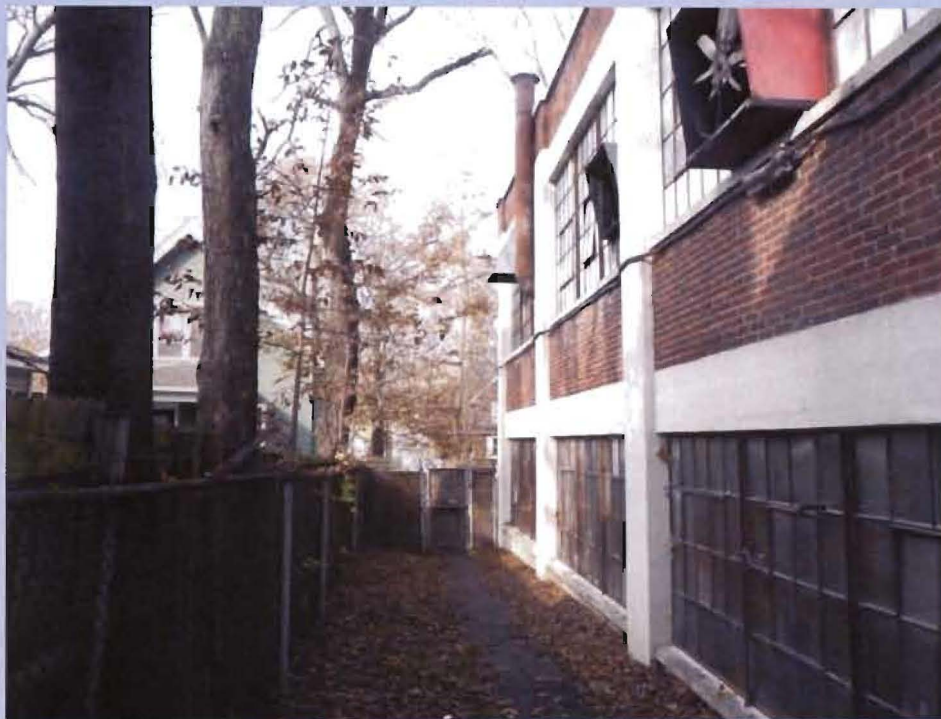
Looking due west at the edge of the Madison-Kipp facility. Note that the property to the left would be 233 Waubesa Street. Note the three vents projecting through the windows and the one vertical vent.

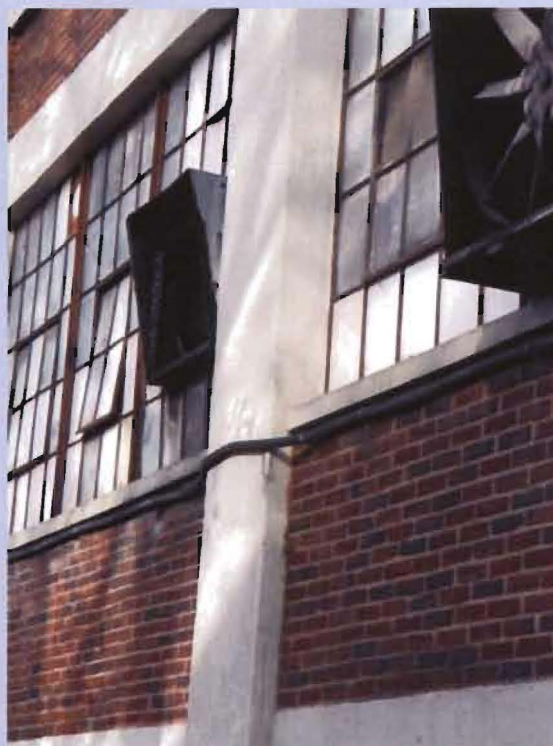
Close-up of the window vents showing the buildup of various petroleum tars caked around the vents.

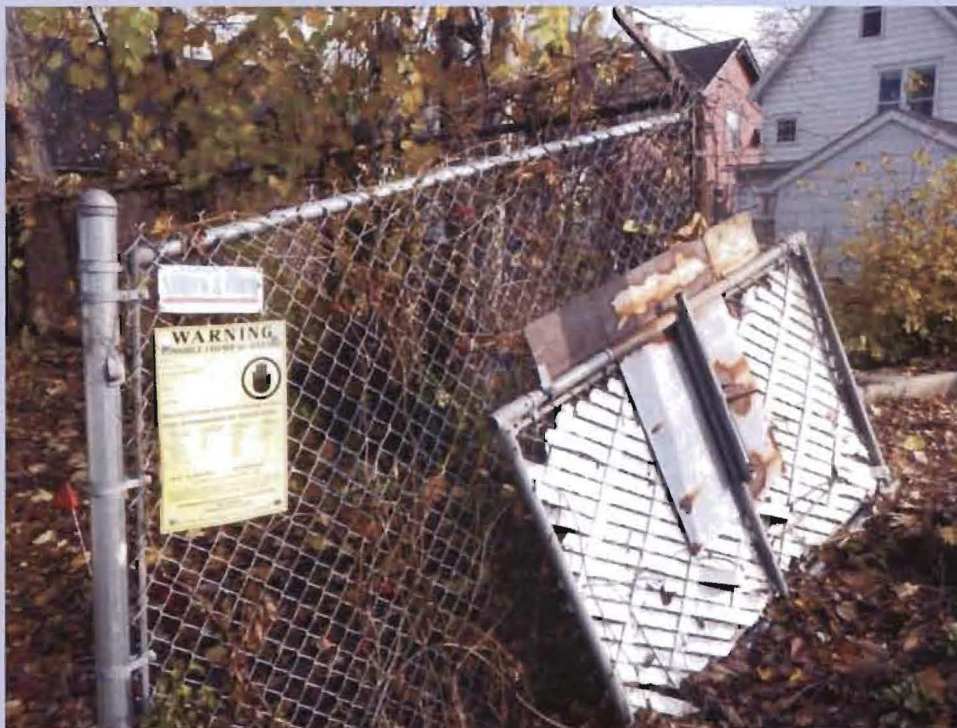
Hazardous waste chemical warning sign placed on the Madison-Kipp property directly adjacent to the homes on Marquette Street.

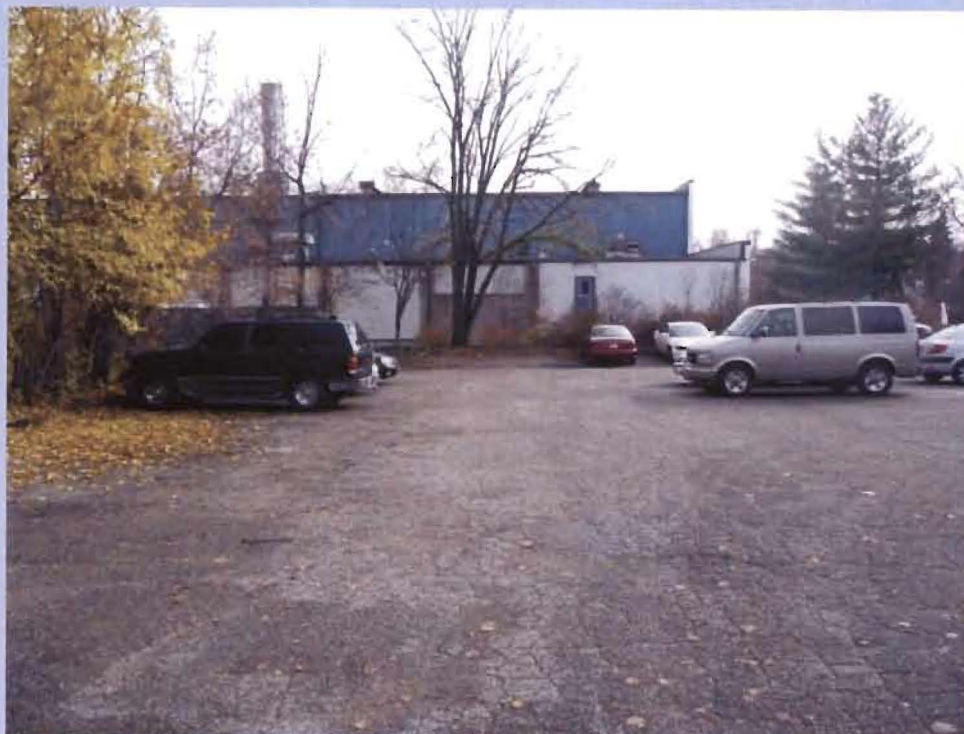
Picture 25

Showing the southwest parking lot part of which is covered by the lower buildings at the back of the picture.

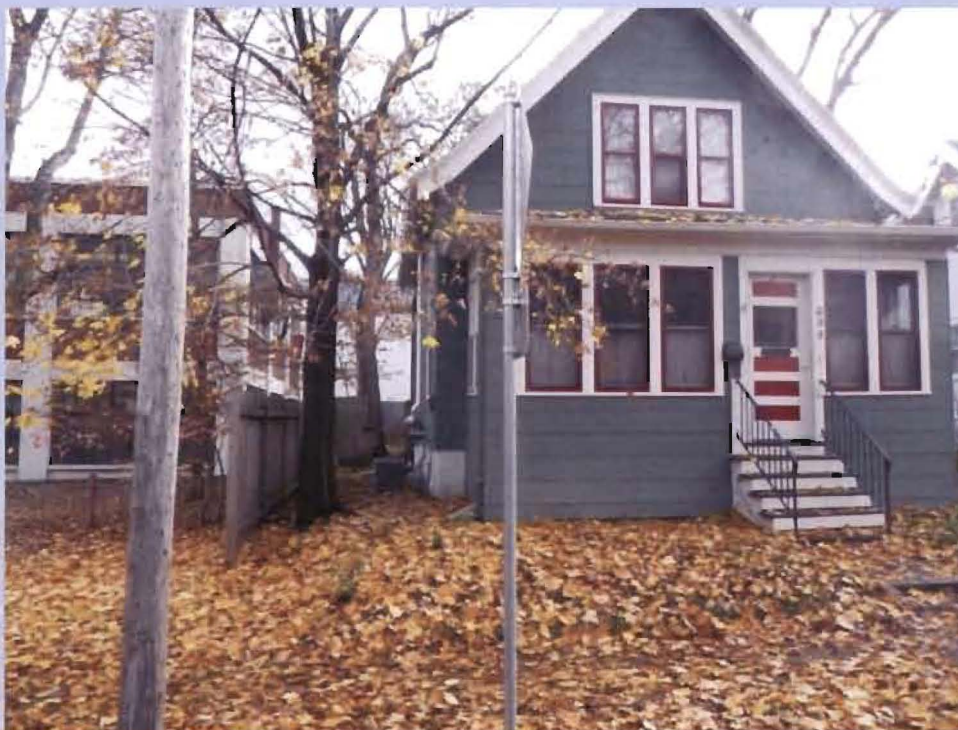
Picture 26

Showing the home at 233 Waubesa Street. Note the vapor depressurization system on the left hand side of the home. Also note the immediate proximity of the Madison Kipp vents located on the Madison-Kipp property.

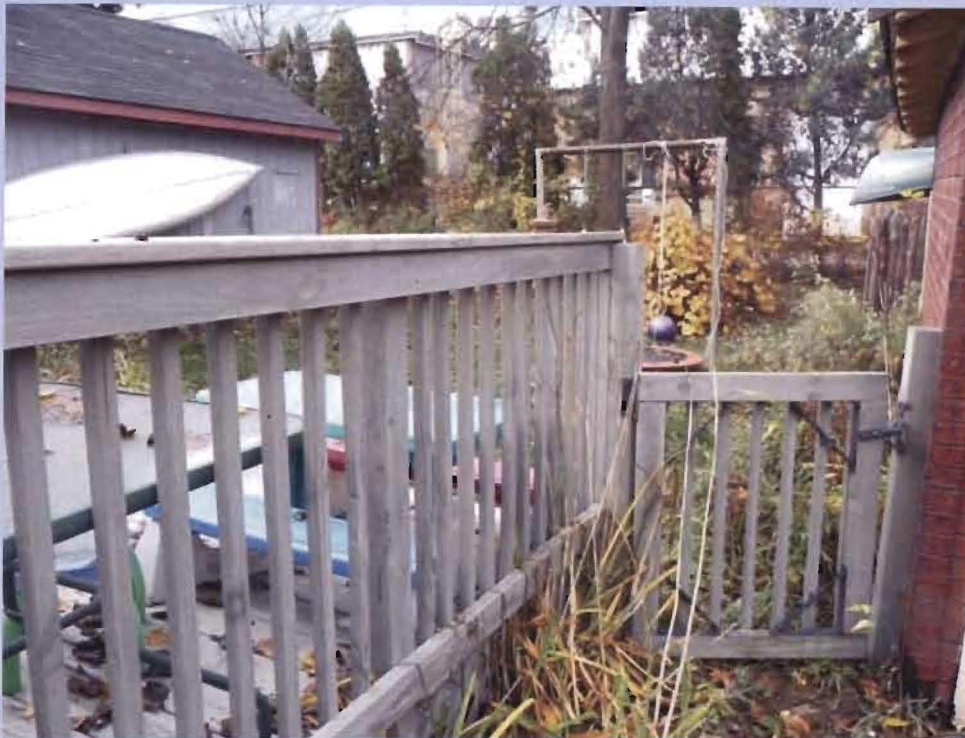
Picture 27

Back yard of one of the homes on Marquette Street showing the proximity of children's play tables, children's play swings, children's play tetherballs, children's trampoline and two boats indicative of outdoorsy athletic families.

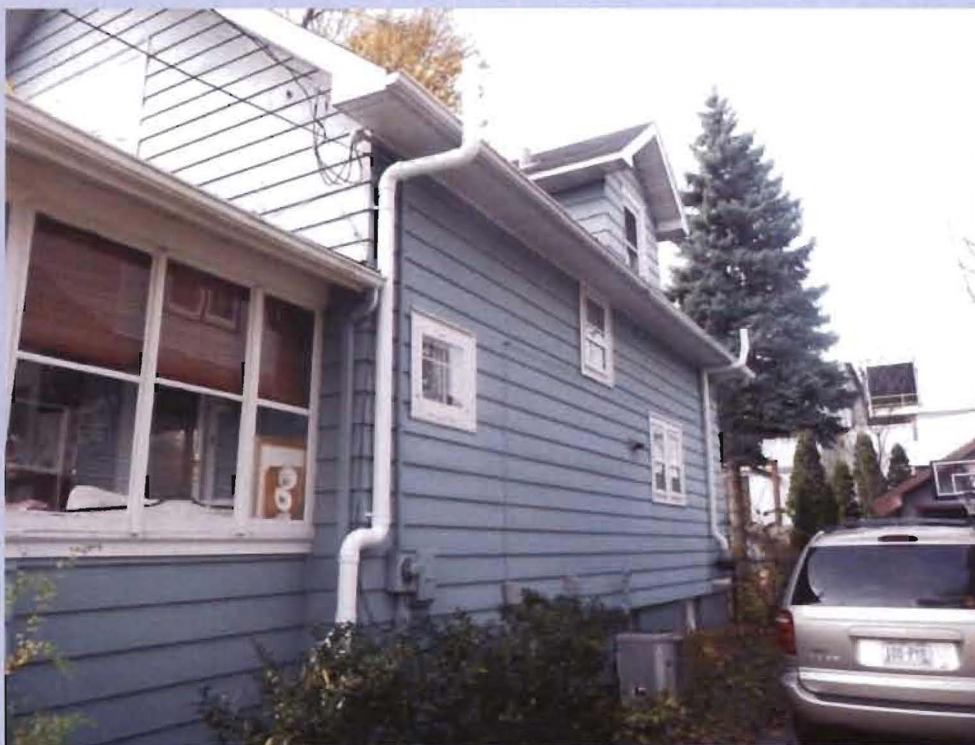
Picture 28

Showing two separate depressurization systems on the north side of this home on Marquette Street. Note the location of the 2 vapor depressurization systems relative to the 2 rain gutter downspouts.

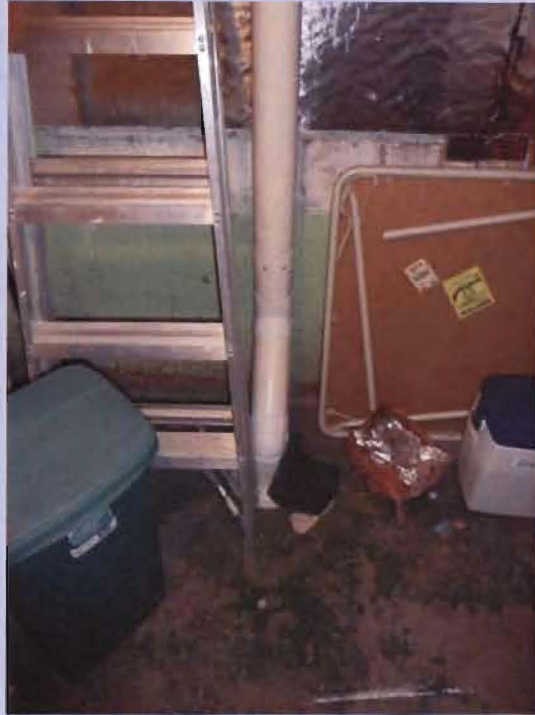
Showing the vapor depressurization system location directly adjacent to the wall. Notice the poor condition of the wall and concrete floor.

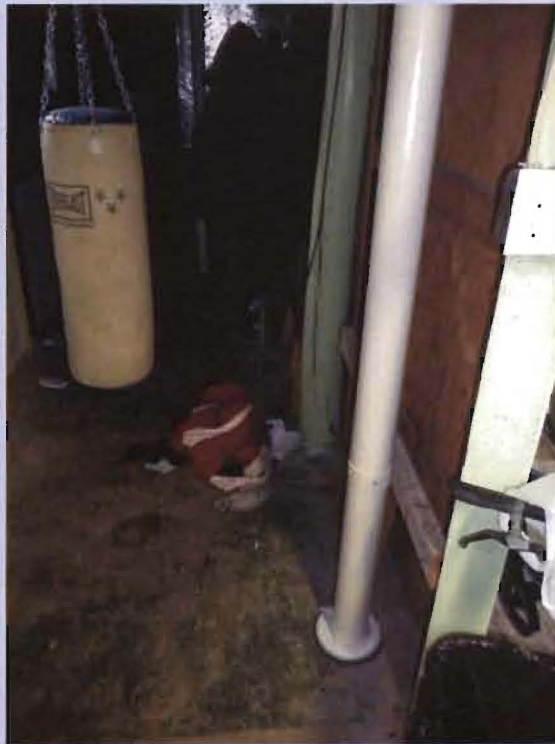
Showing a second location for the depressurization system in a clients home.

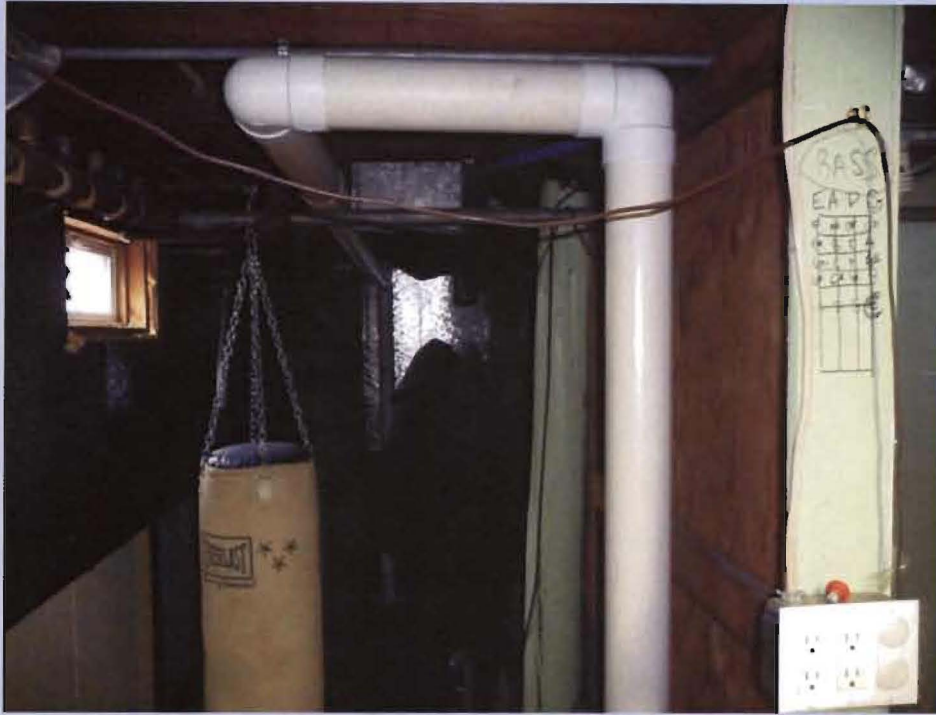
Showing how the two vapor extraction locations are plumbed together to the outside.

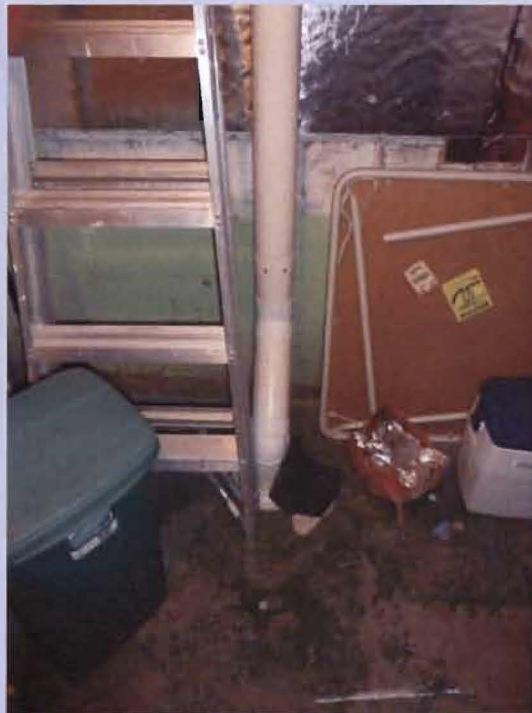
Showing the vapor depressurization system location directly adjacent to the wall. Notice the poor condition of the wall and the concrete floor.

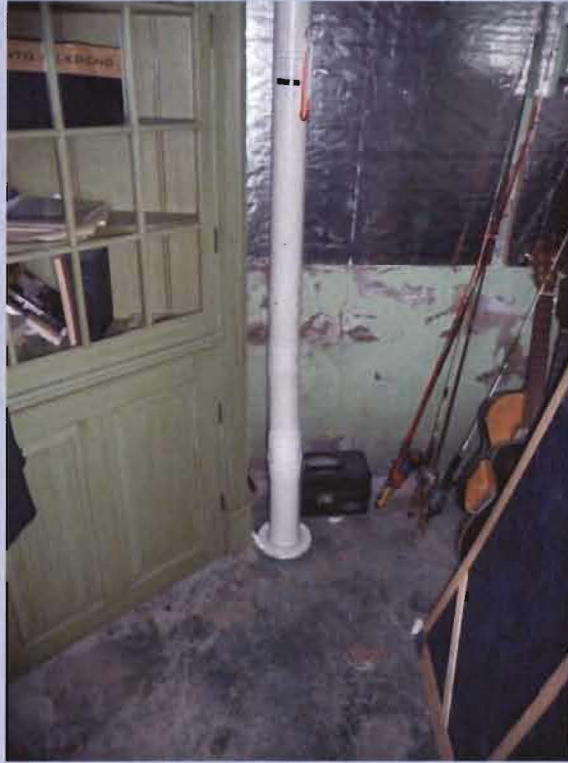
Showing a vapor extraction system. Note the condition of the concrete wall in the background and the condition of the floor.

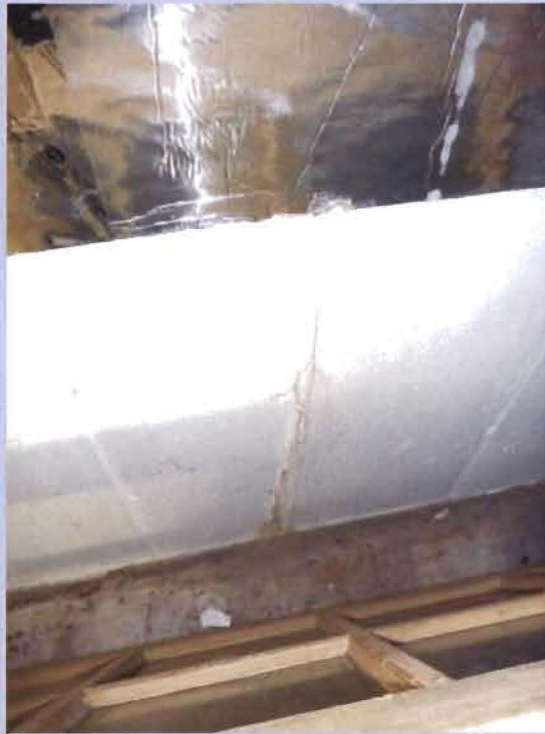
Showing the cracks in the concrete wall and the seepage of moisture through the cracks.

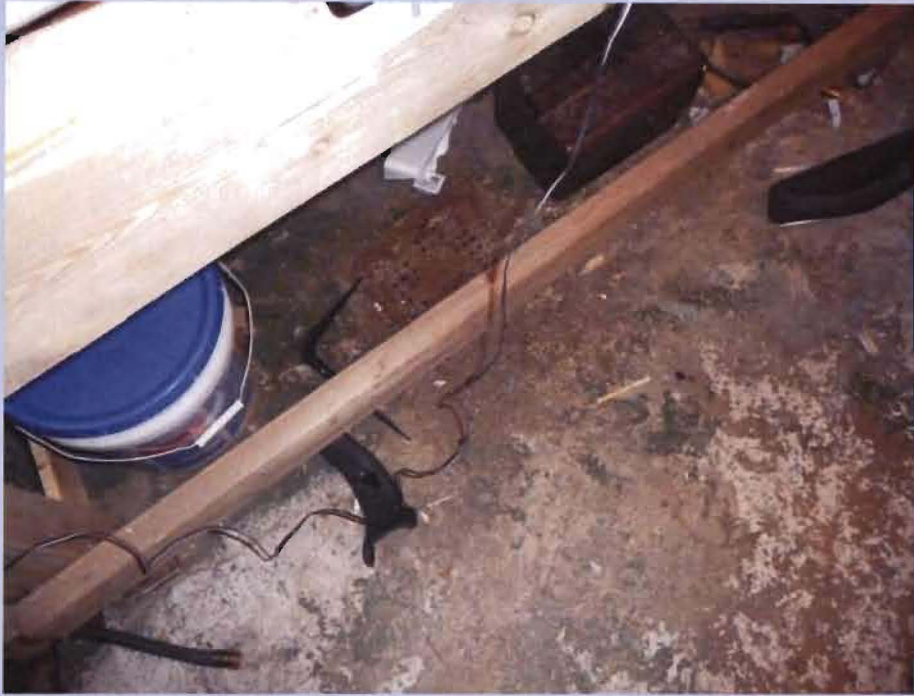
Shows the presence of floor drains in the basements which would act as conduits for vapor to enter the buildings.

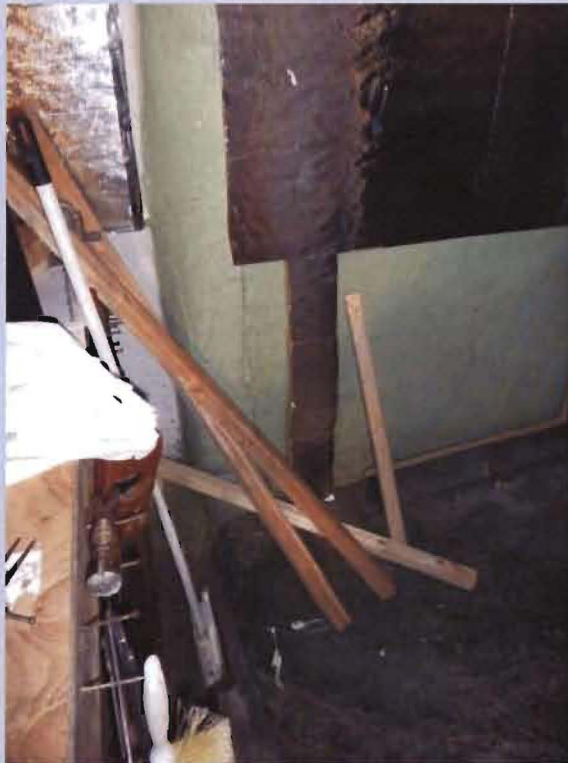
Showing the condition of the concrete in the basement. The cracks in the wall would allow contaminated vapors to enter the basement.
