RJN Environmental Services, LLC

MADISON-KIPP CORPORATION
MADISON, WISCONSIN
GROUNDWATER MONITOR WELL LOCATIONS

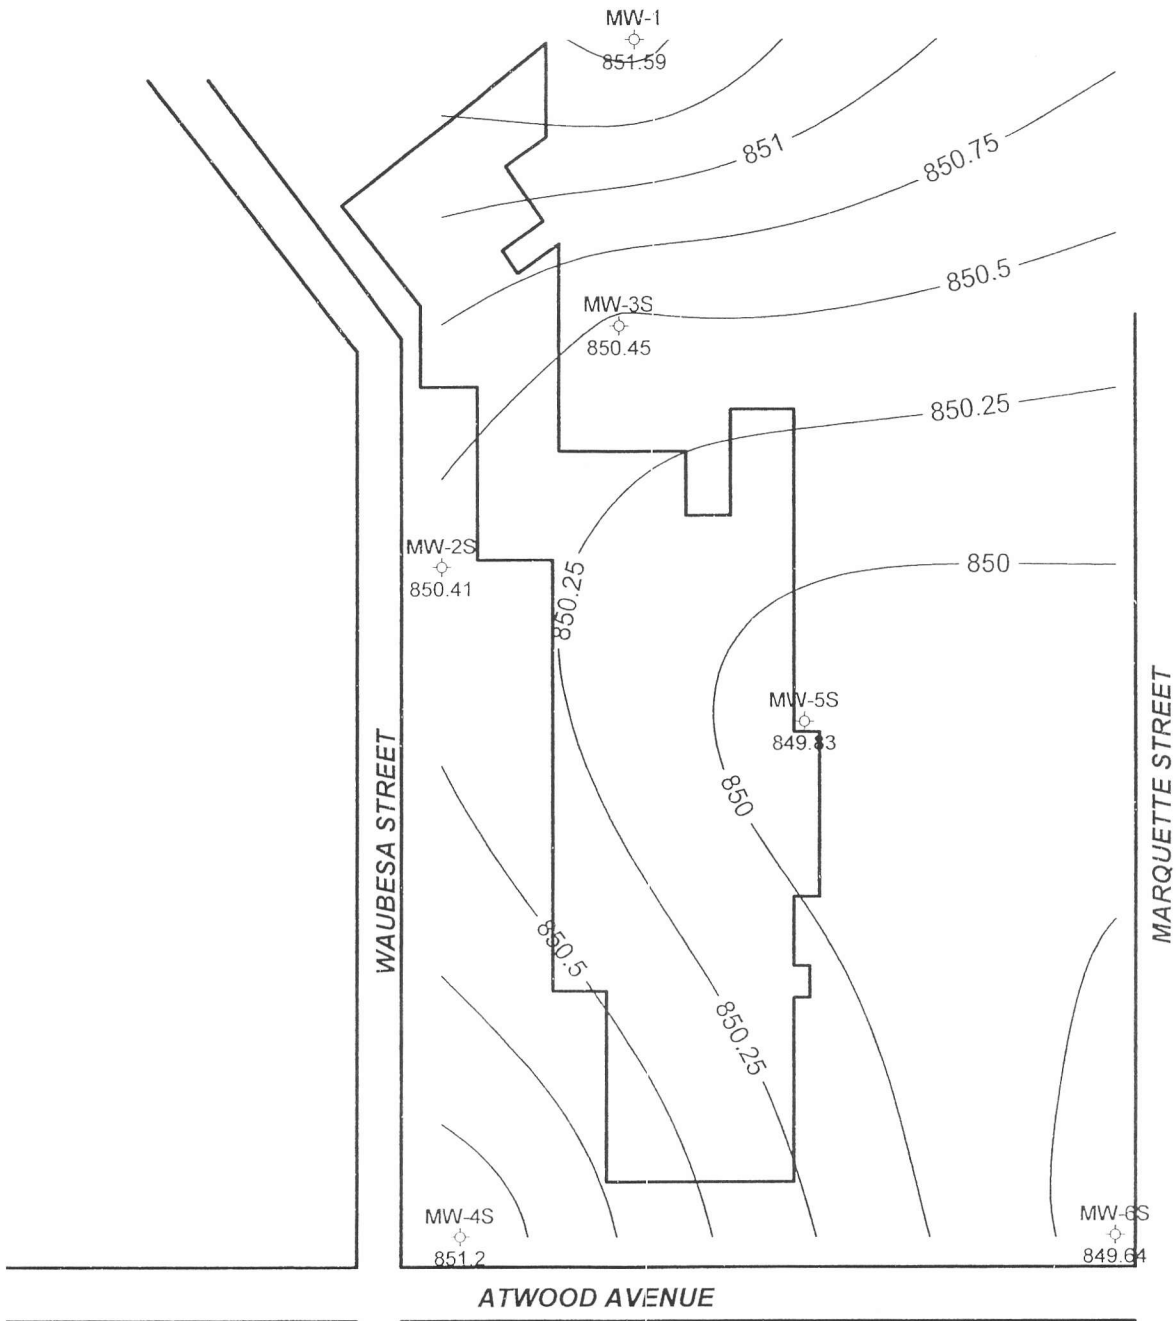
MONITOR WELL WITH GROUNDWATER ELEVATION (FT, MSL)

845 GROUNDWATER ELEVATION (FEET, MSL)

MADISON-KIPP CORP. MADISON, WISCONSIN WATER TABLE JULY 1, 2010			FIGURE 2
DRAWN BY	PROJ. No.	DATE	FILE NAME
RN	09-101	07 JAN 11	WT 070110

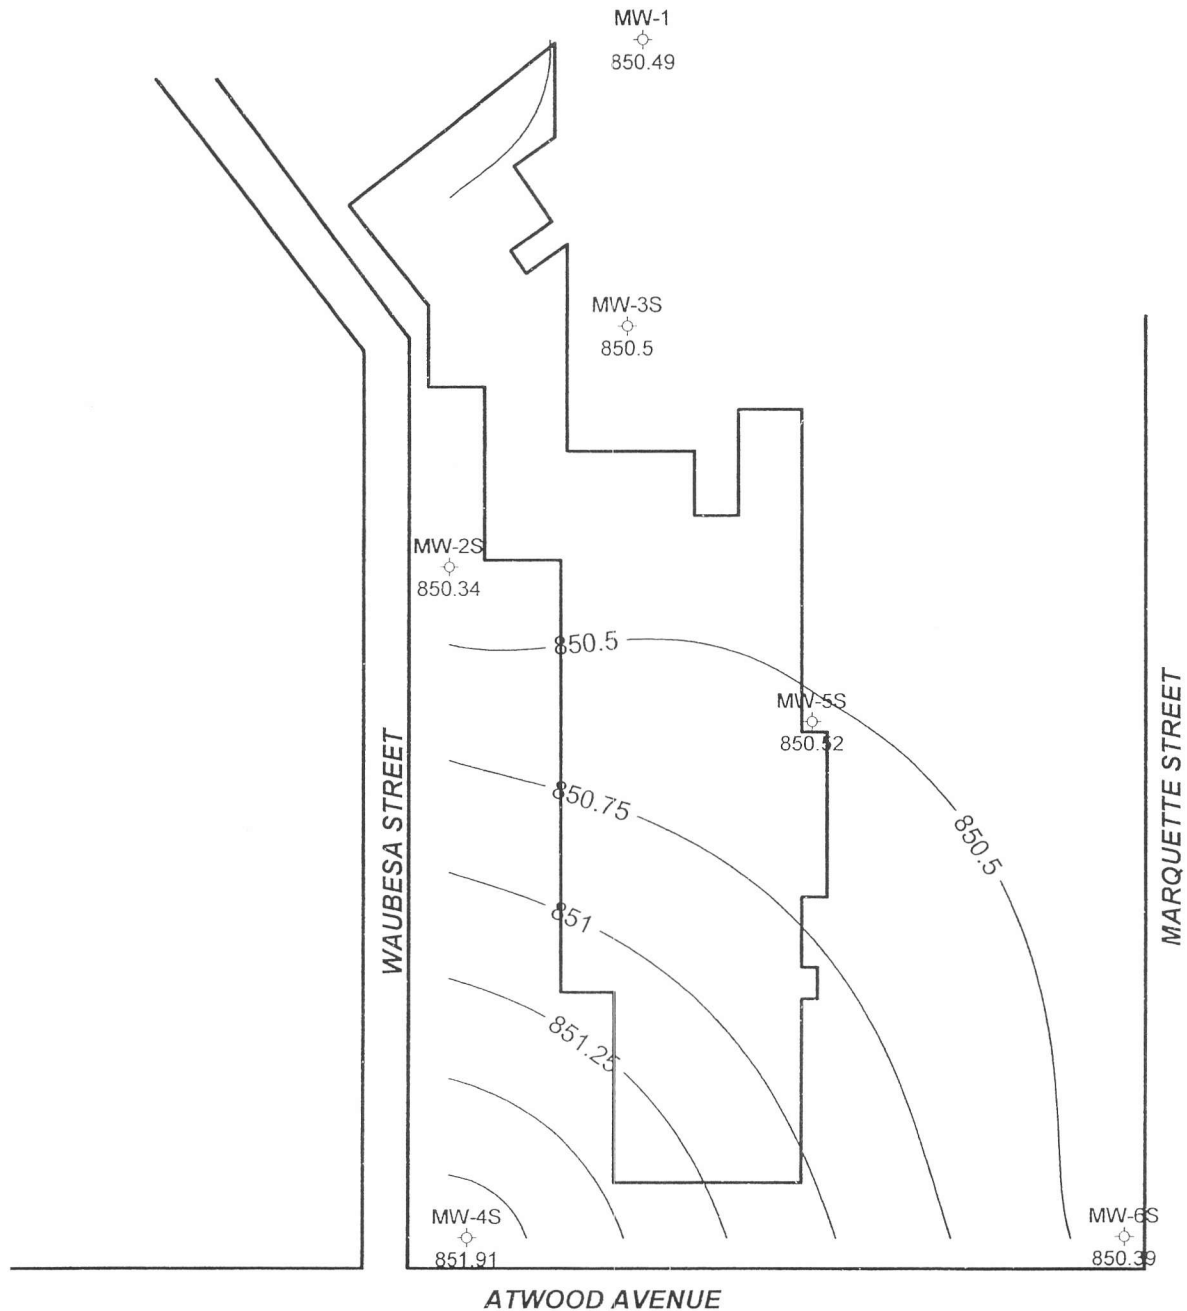
FIGURE
3

844.21 MONITOR WELL WITH
GROUNDWATER ELEVATION (FT, MSL)
 845 GROUNDWATER ELEVATION
(FEET, MSL)

MADISON-KIPP CORP.
MADISON, WISCONSIN
WATER TABLE
OCTOBER 1, 2010

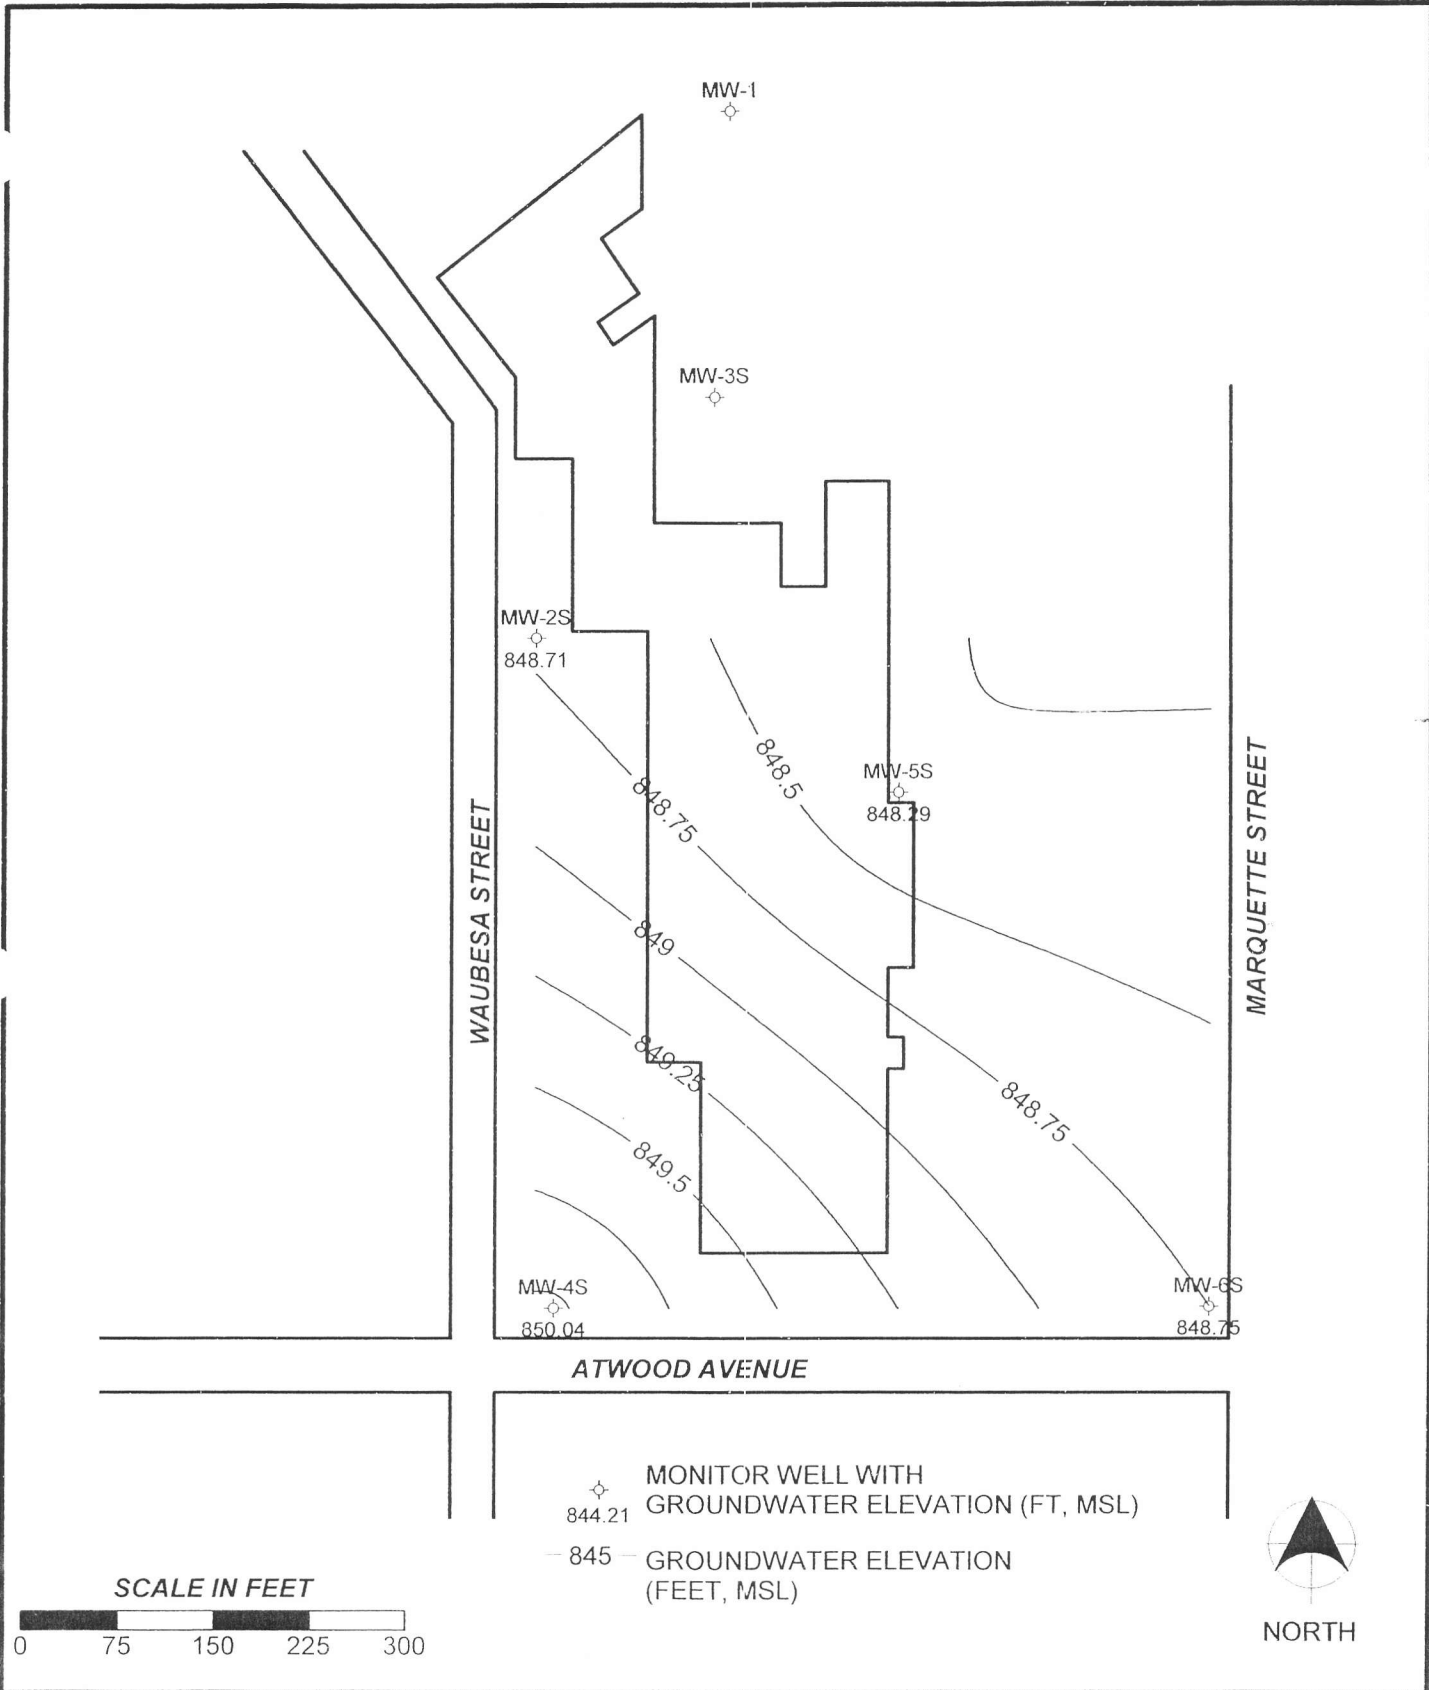
FIGURE
4

MADISON-KIPP CORP. MADISON, WISCONSIN WATER TABLE DECEMBER 28, 2010			
DRAWN BY	PROJ. No.	DATE	FILE NAME
RN	09-101	07 JAN 11	WT 122810

MONITOR WELL WITH
 GROUNDWATER ELEVATION (FT, MSL)
 — 845 — GROUNDWATER ELEVATION
 (FEET, MSL)

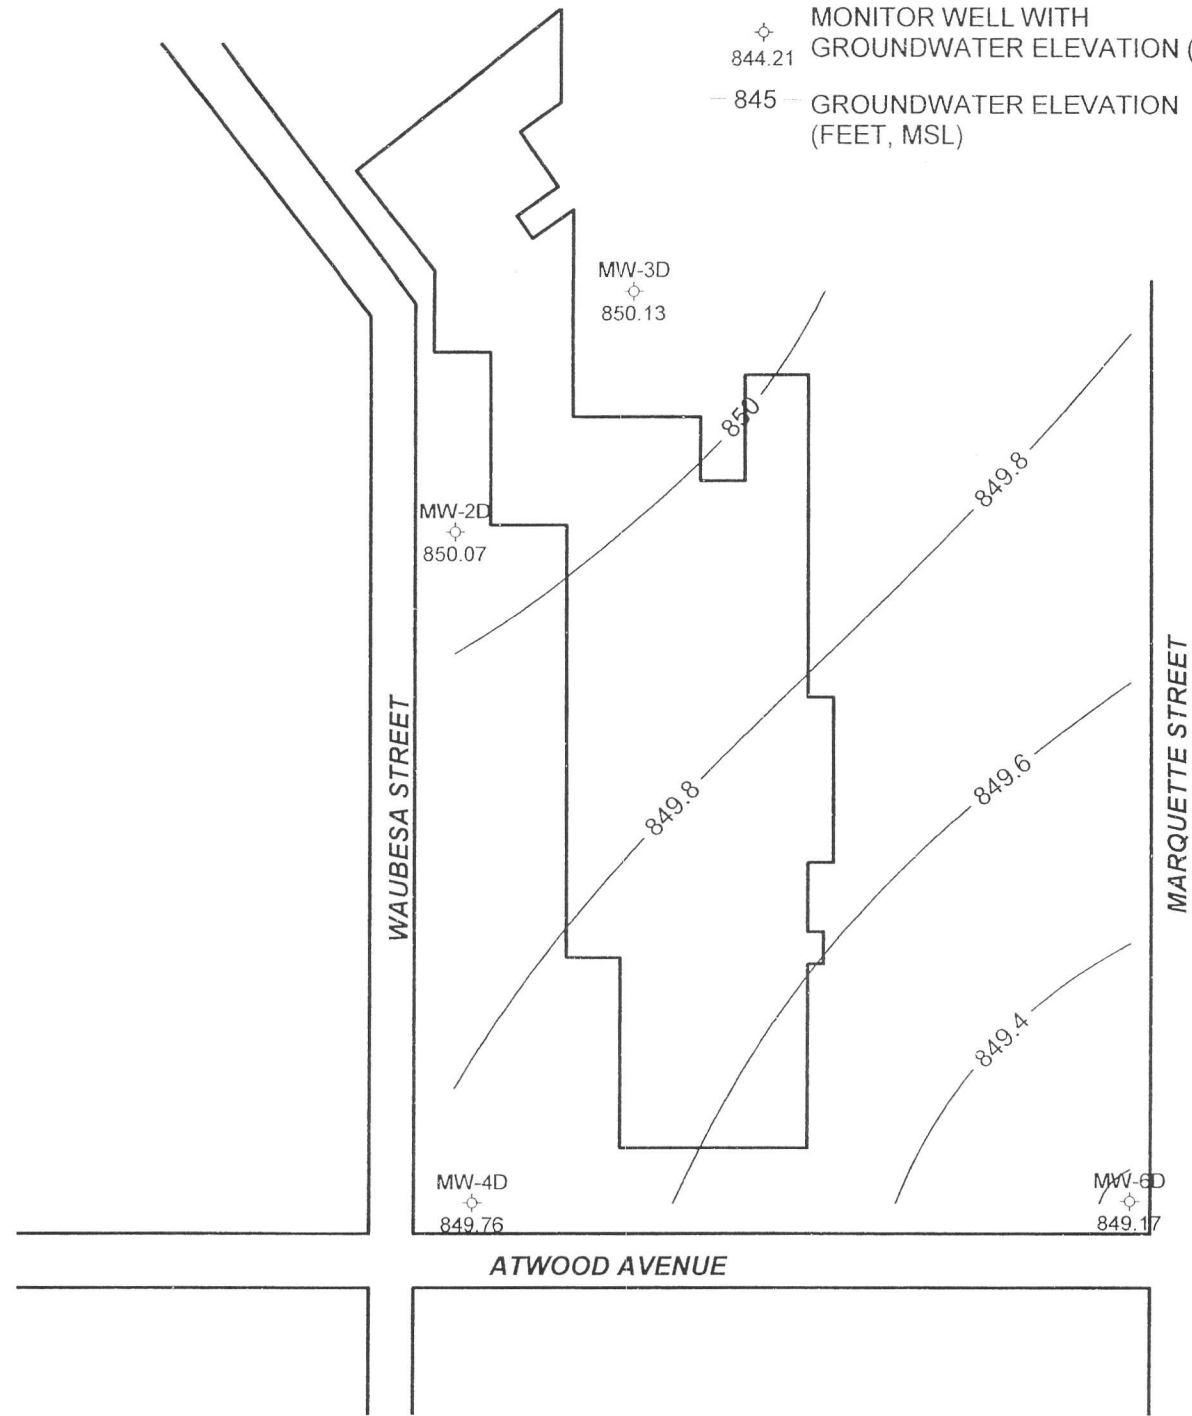
<p> RIN Environmental Services, LLC Surface Water Studies Groundwater Studies Site Investigations 4631 COUNTY ROAD A OREGON, WISCONSIN 53575 (608) 676-3001 </p>	MADISON-KIPP CORPORATION MADISON, WISCONSIN INTERMEDIATE WATER LEVELS JULY 1, 2010			FIGURE 5
	DRAWN BY	PROJ. No.	DATE	FILE NAME
	RN	09-101	07 JAN 11	INT 070110

MONITOR WELL WITH
 844.21 GROUNDWATER ELEVATION (FT, MSL)
 — 845 — GROUNDWATER ELEVATION
 (FEET, MSL)

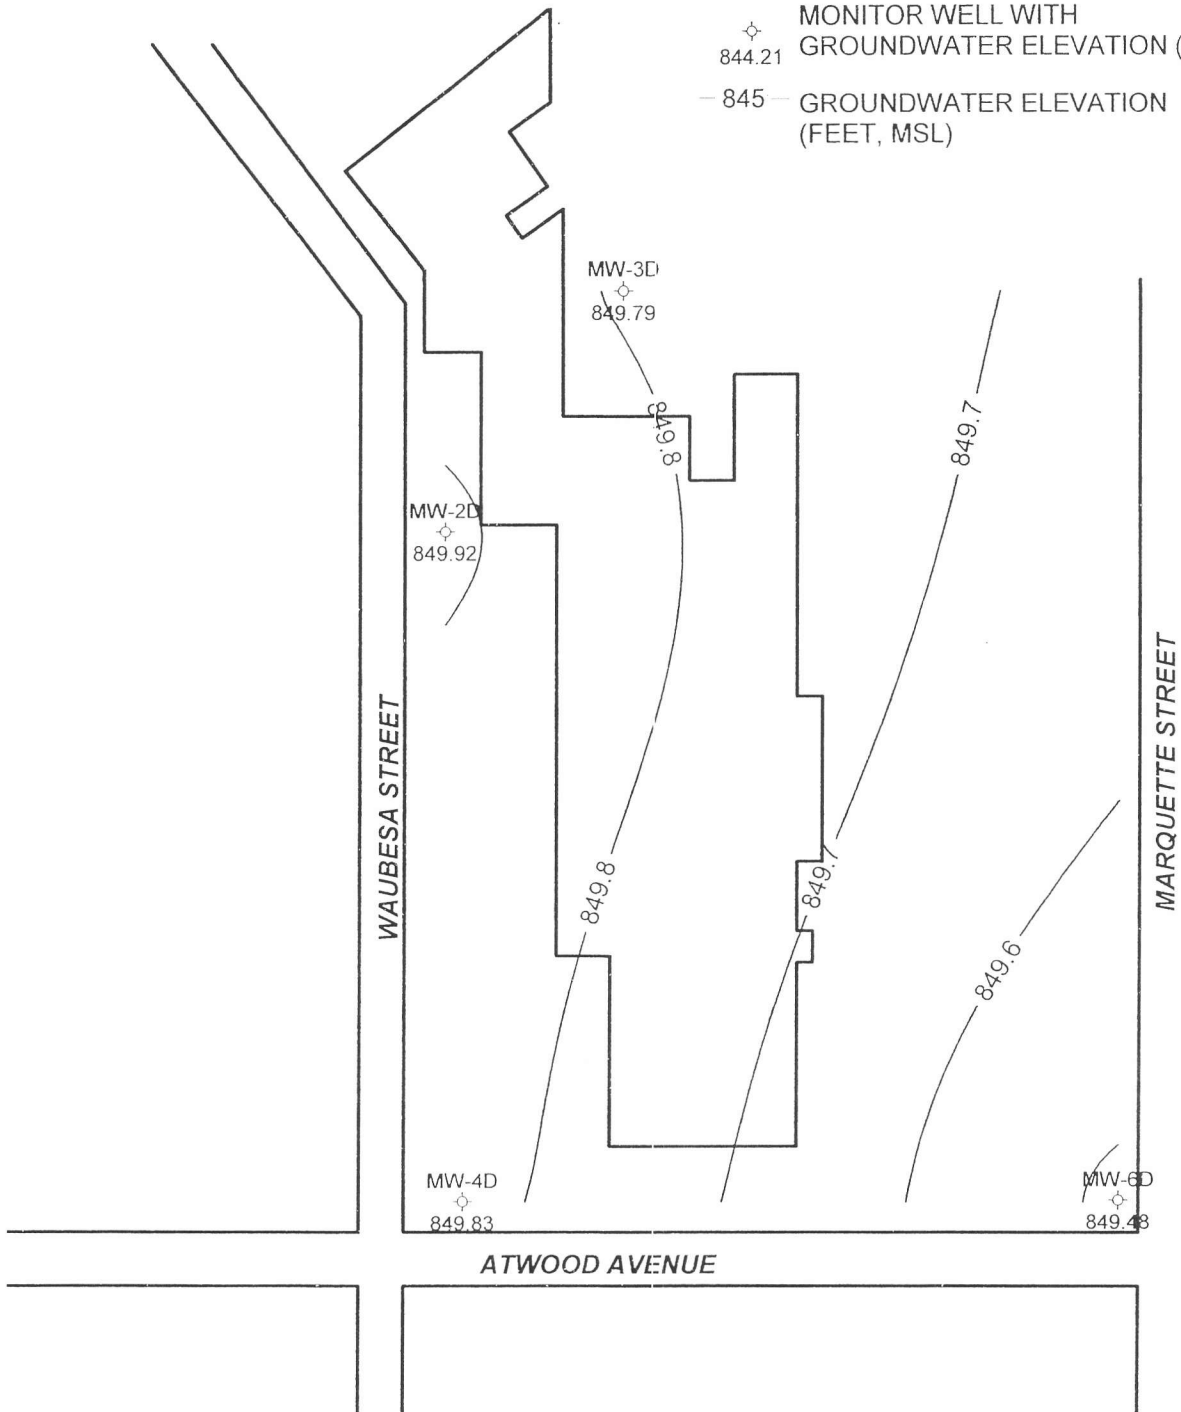
FIGURE
6

MADISON-KIPP CORPORATION
 MADISON, WISCONSIN
 INTERMEDIATE WATER LEVELS
 OCTOBER 1, 2010

MONITOR WELL WITH
 844.21 GROUNDWATER ELEVATION (FT, MSL)
 — 845 — GROUNDWATER ELEVATION
 (FEET, MSL)

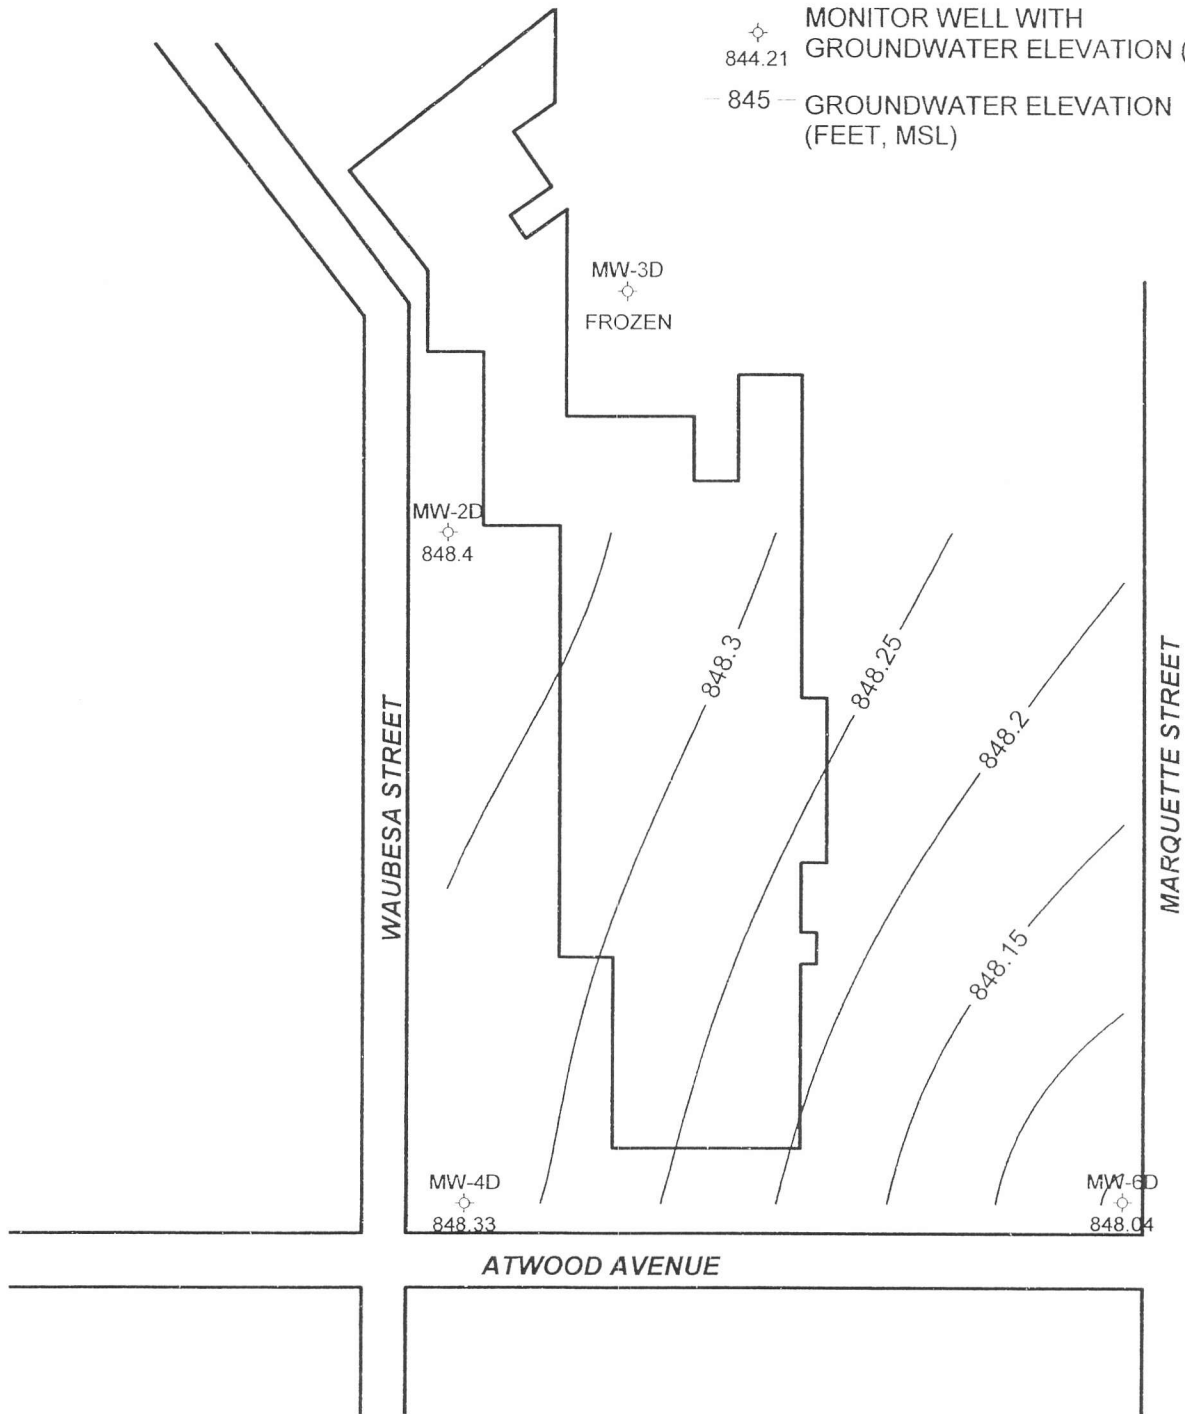
FIGURE
7

MADISON-KIPP CORPORATION
 MADISON, WISCONSIN
 INTERMEDIATE WATER LEVELS
 DECEMBER 28, 2010

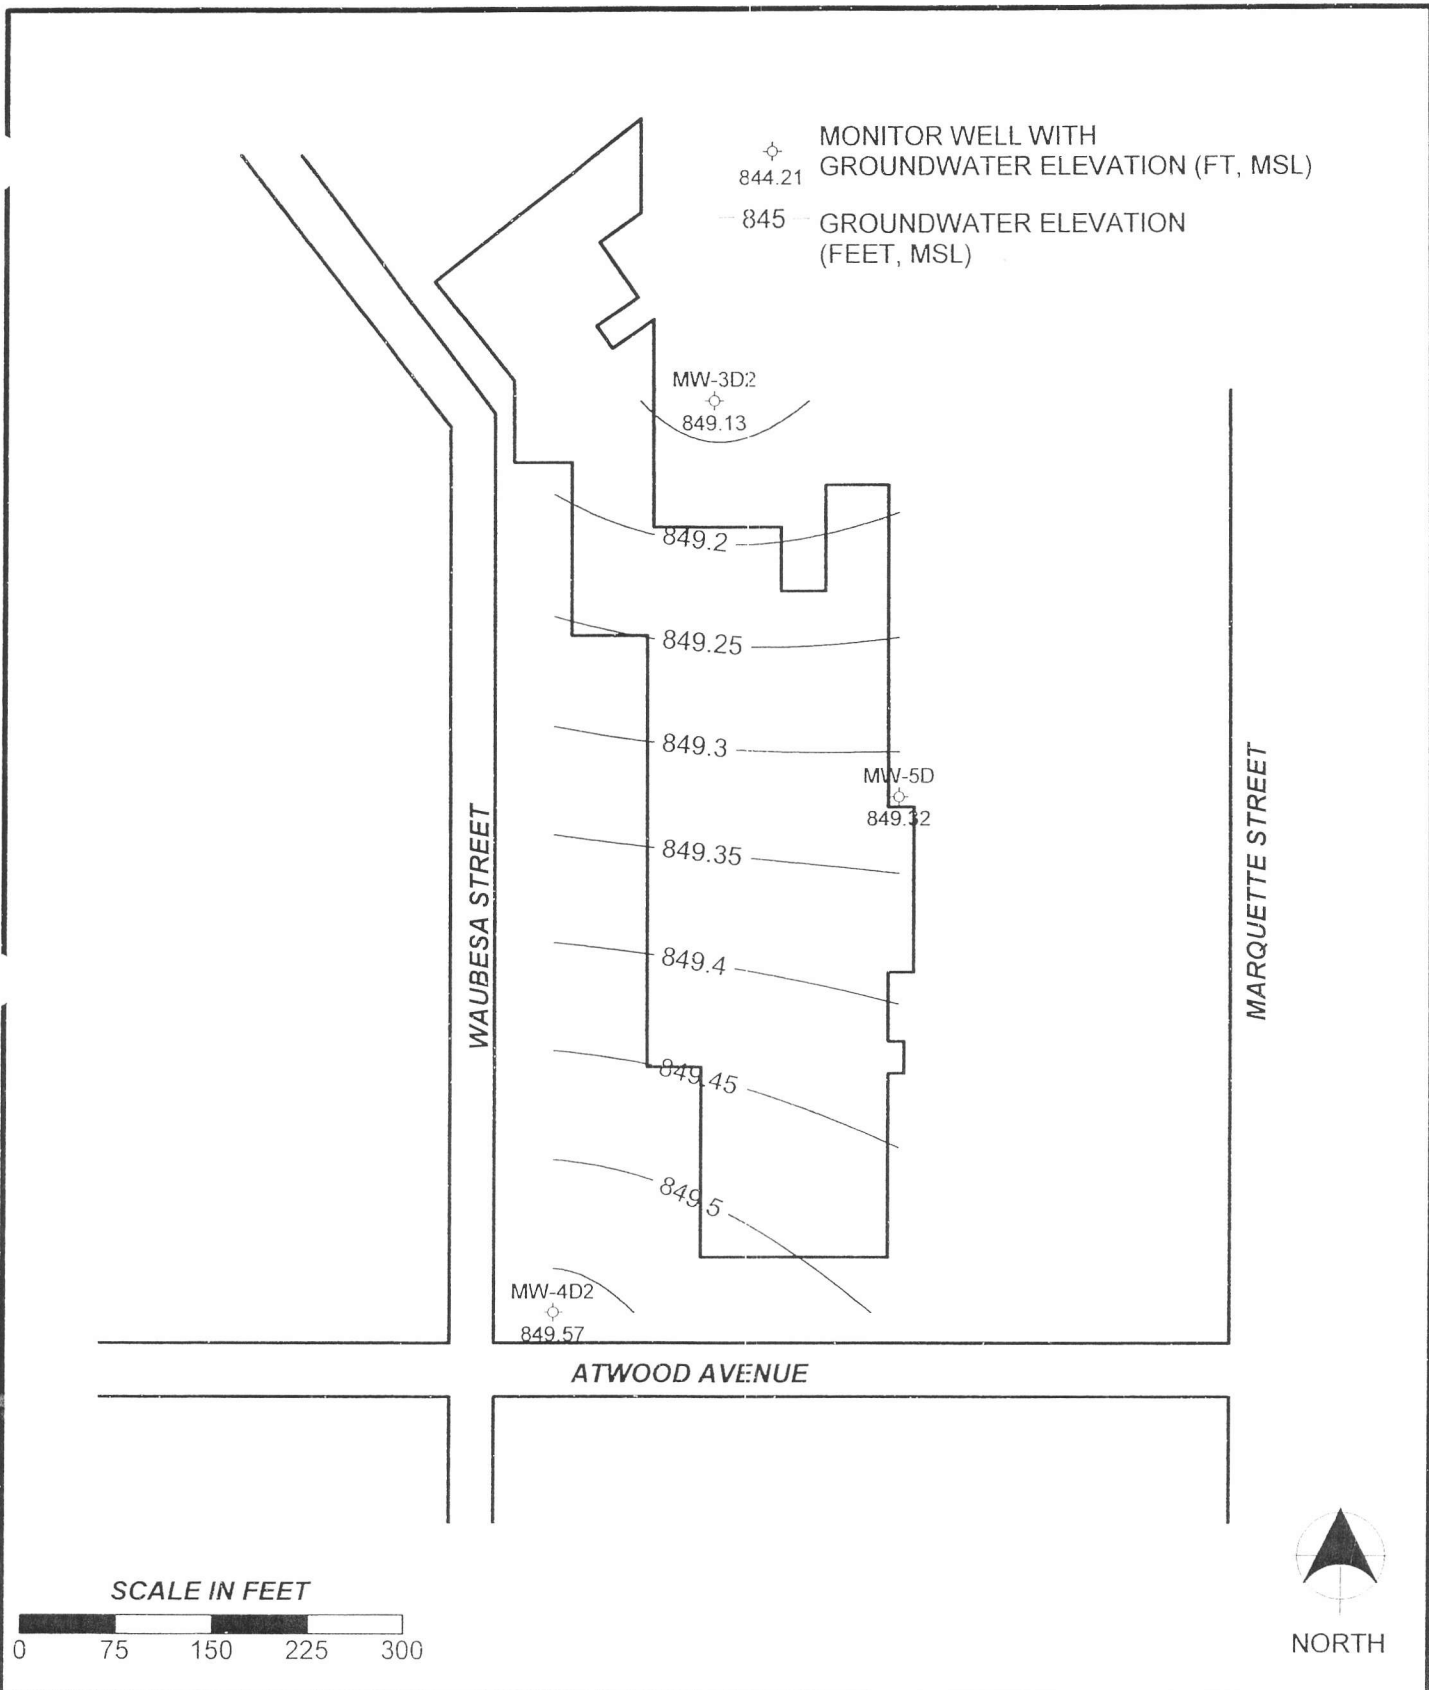
FIGURE
8

MADISON-KIPP CORPORATION MADISON, WISCONSIN DEEP WATER LEVELS JULY 1, 2010		
DRAWN BY	PROJ. No.	DATE
RN	09-101	07 JAN 11

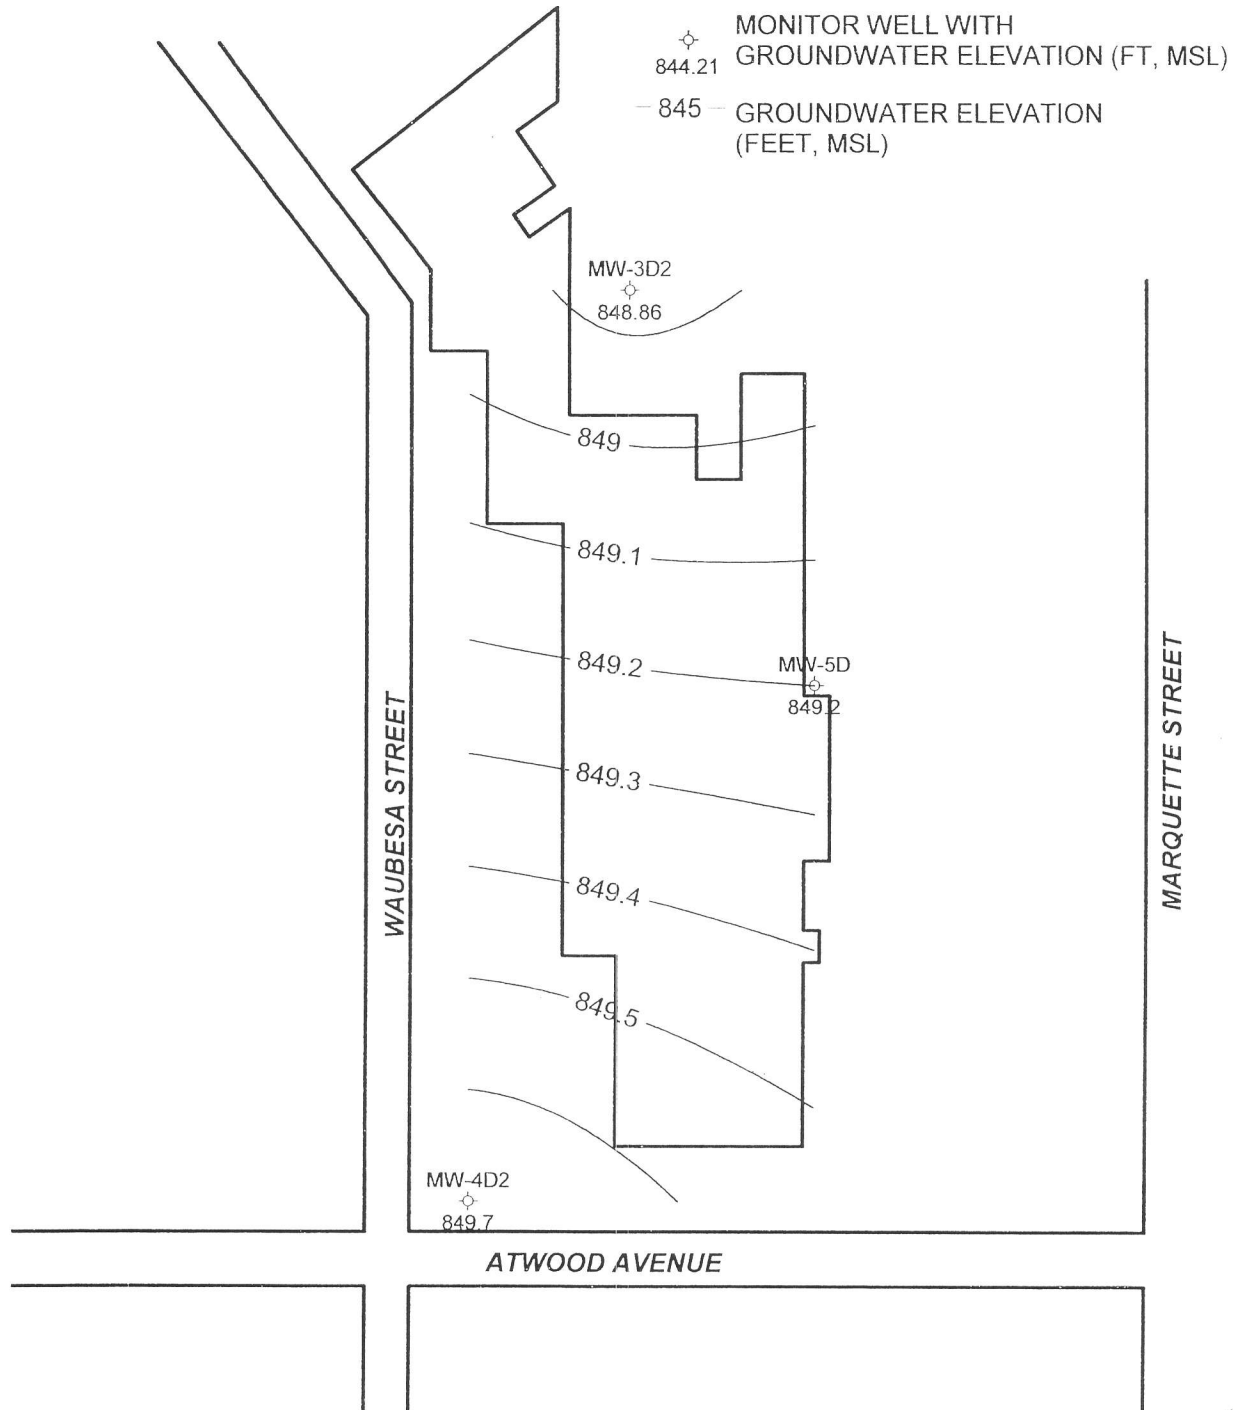
FIGURE
 9

MADISON-KIPP CORPORATION
 MADISON, WISCONSIN
 DEEP WATER LEVELS
 OCTOBER 1, 2010

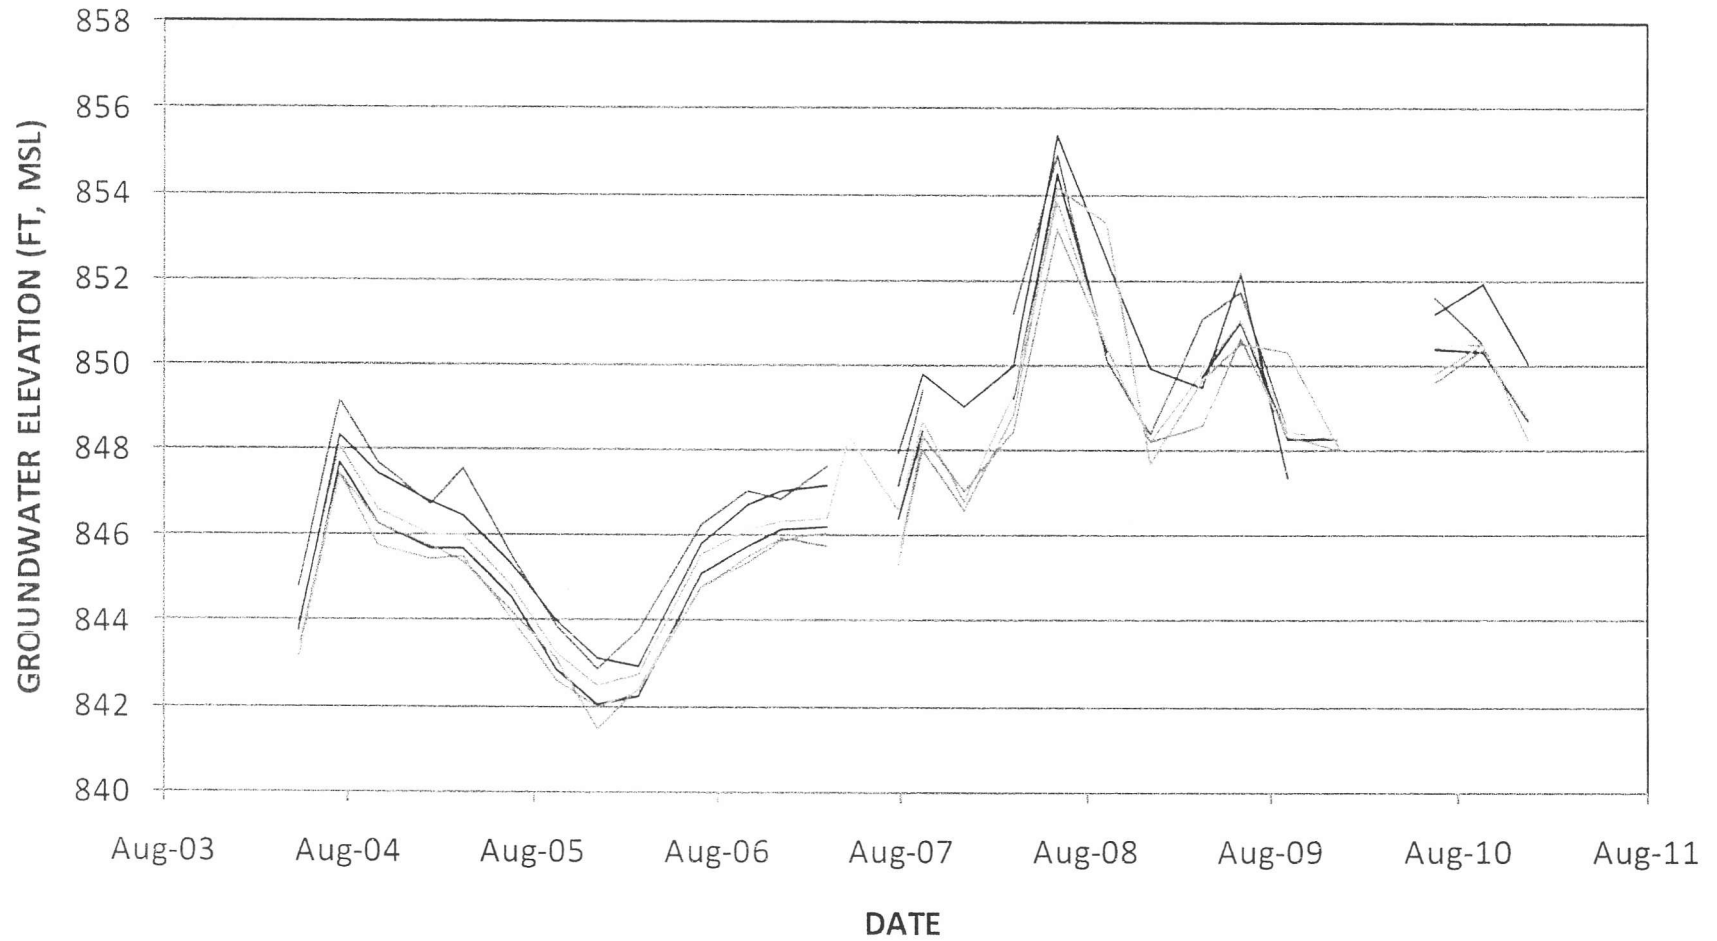
FIGURE
10

— MW-1 — MW-2S — MW-3S — MW-4S — MW-5S — MW-6S

MADISON-KIPP CORPORATION
MADISON, WISCONSIN
SHALLOW WELL HYDROGRAPHS

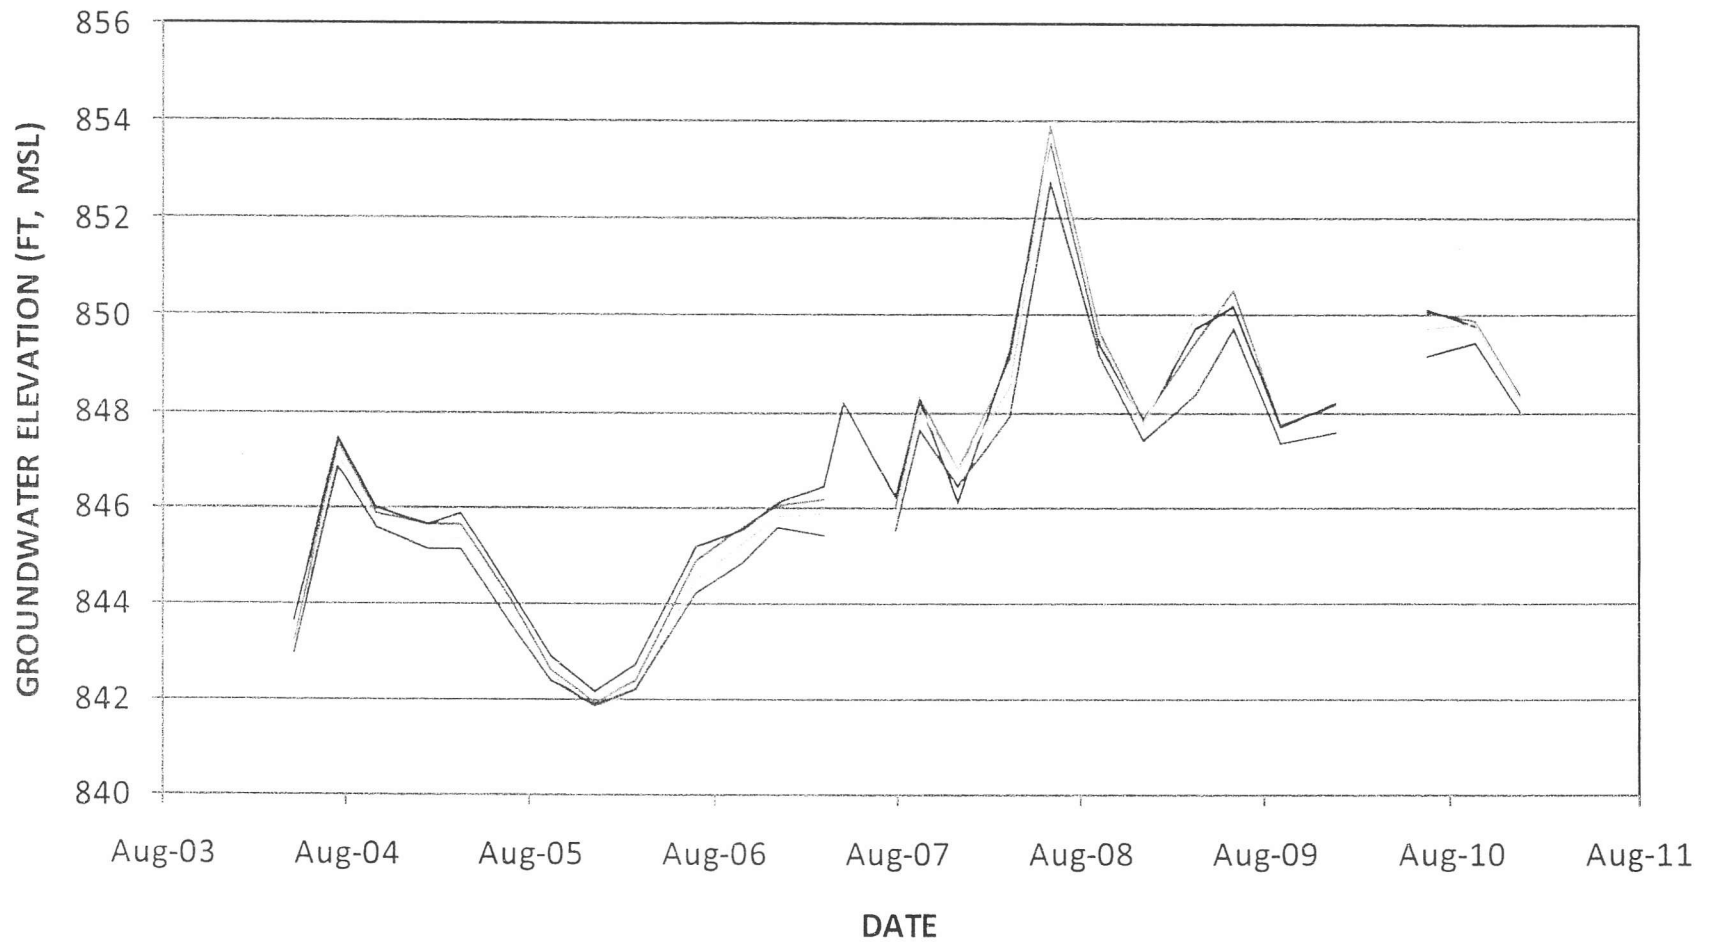
FIGURE
11

— MW-2D — MW-3D — MW-4D — MW-6D

MADISON-KIPP CORPORATION
 MADISON, WISCONSIN
 INTERMEDIATE WELL HYDROGRAPHS

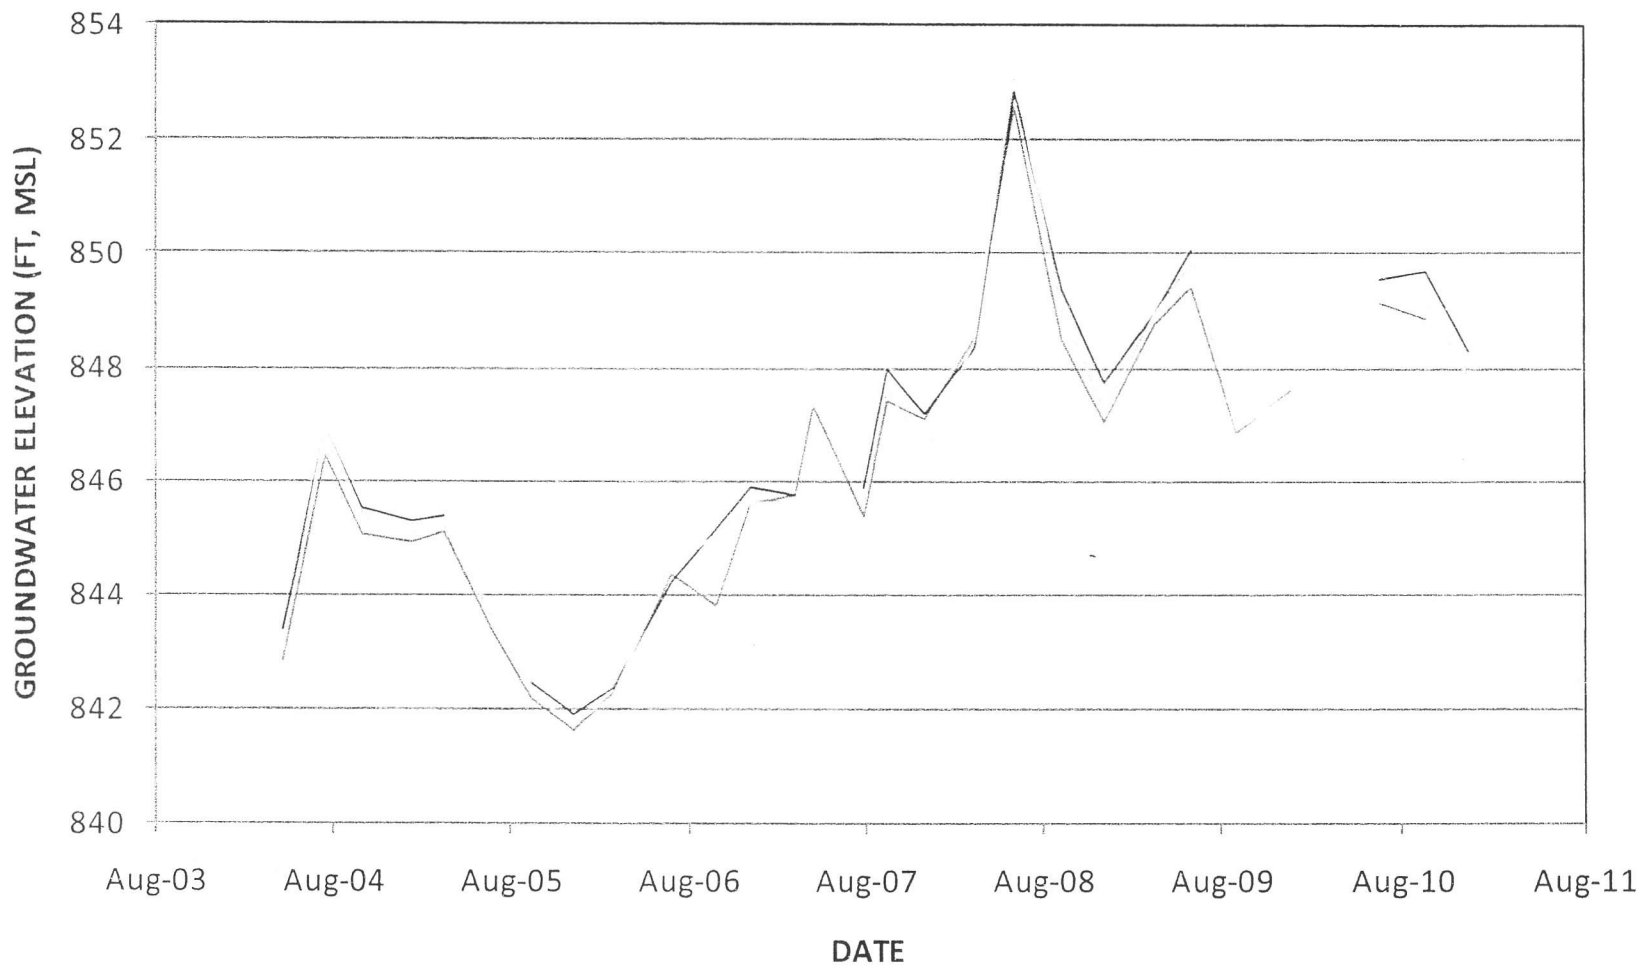
FIGURE
12

— MW-3D2 — MW-4D2 — MW-5D

MADISON-KIPP CORPORATION
MADISON, WISCONSIN
DEEP WELL HYDROGRAPHS

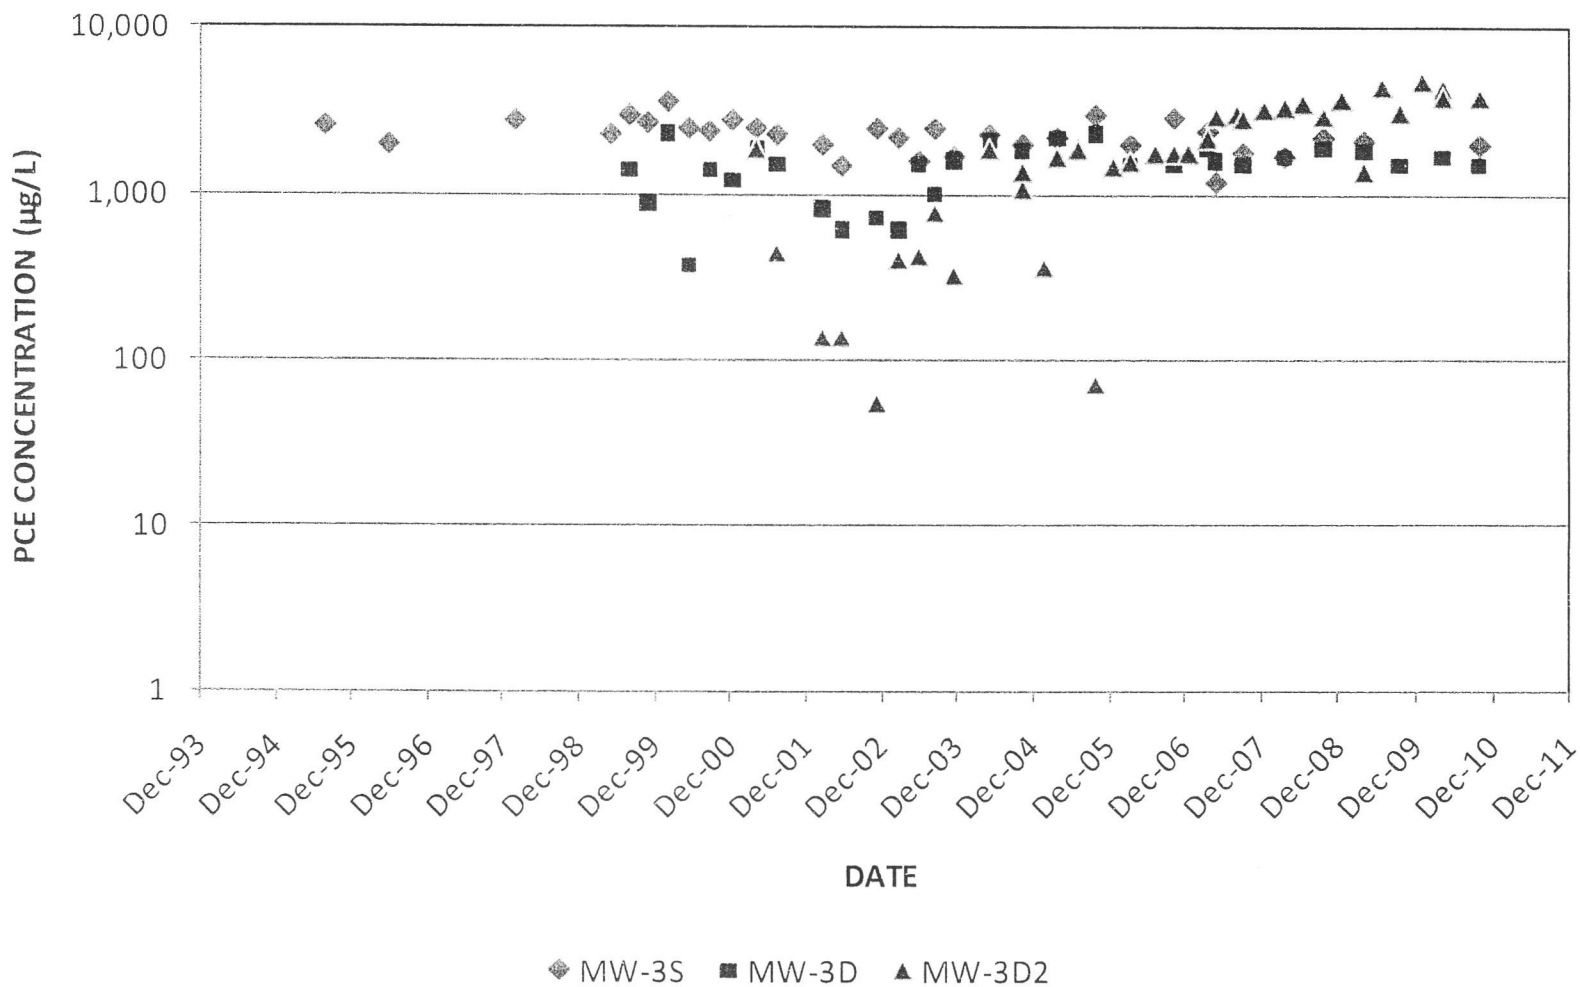
MADISON-KIPP CORPORATION
MADISON, WISCONSIN
PCE CONCENTRATIONS - MW-3 NEST

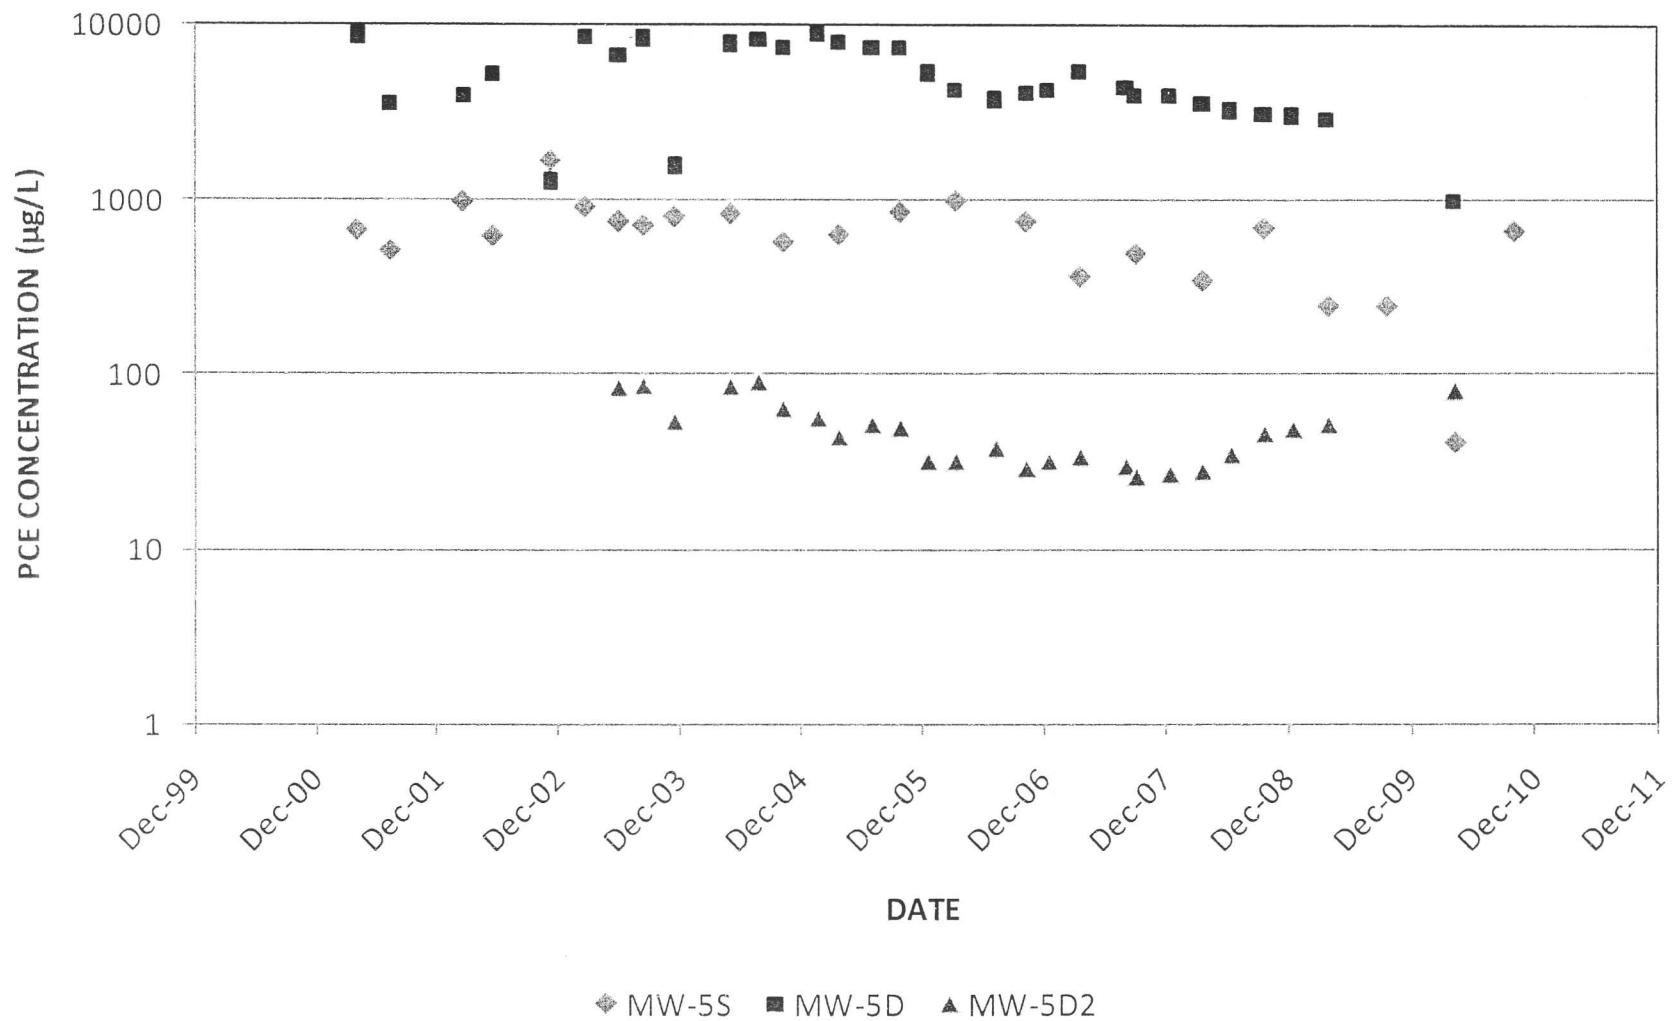
FIGURE
14

MADISON-KIPP CORPORATION
MADISON, WISCONSIN
PCE CONCENTRATIONS - MW-5 NEST
